BASSETL. DISTRICT COUNC December 2012

Title:	Listed Buildings at Risk in Bassetlaw 2012.
Summary:	This document provide service users with information about how redundant, vulnerable or decay historic buildings and a register of which buildings are currently regarded as being at risk by the Council.
Approved:	This document was approved by Planning Committee on 6 <sup>th</sup> February 2013 at Retford Town Hall. The document was published on 7 <sup>th</sup> February 2013.

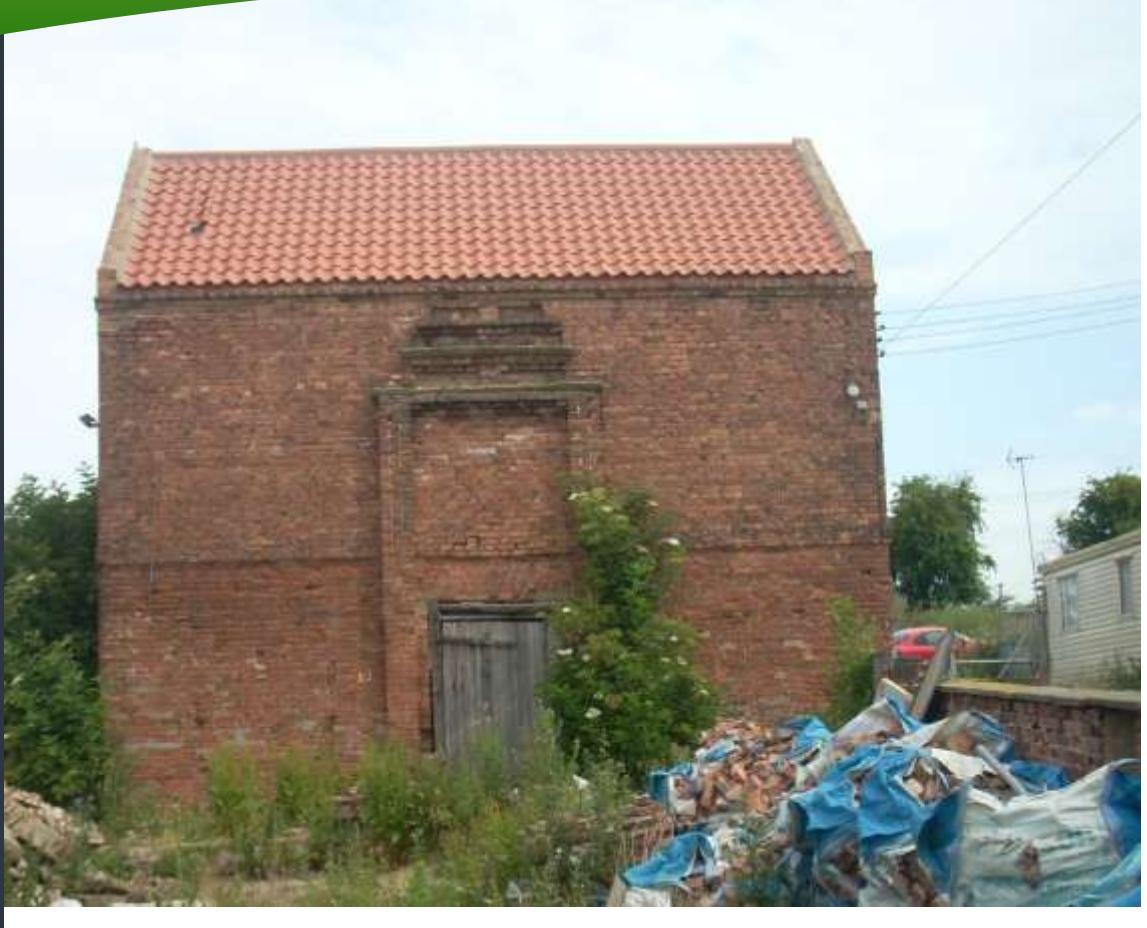
Currently used for storage. Roof repaired and rear fodder store rebuilt 2005. Crack in masonry above lintel (at string course) of front doorway. Overall, structure is sound but in need of repairs/maintenance.

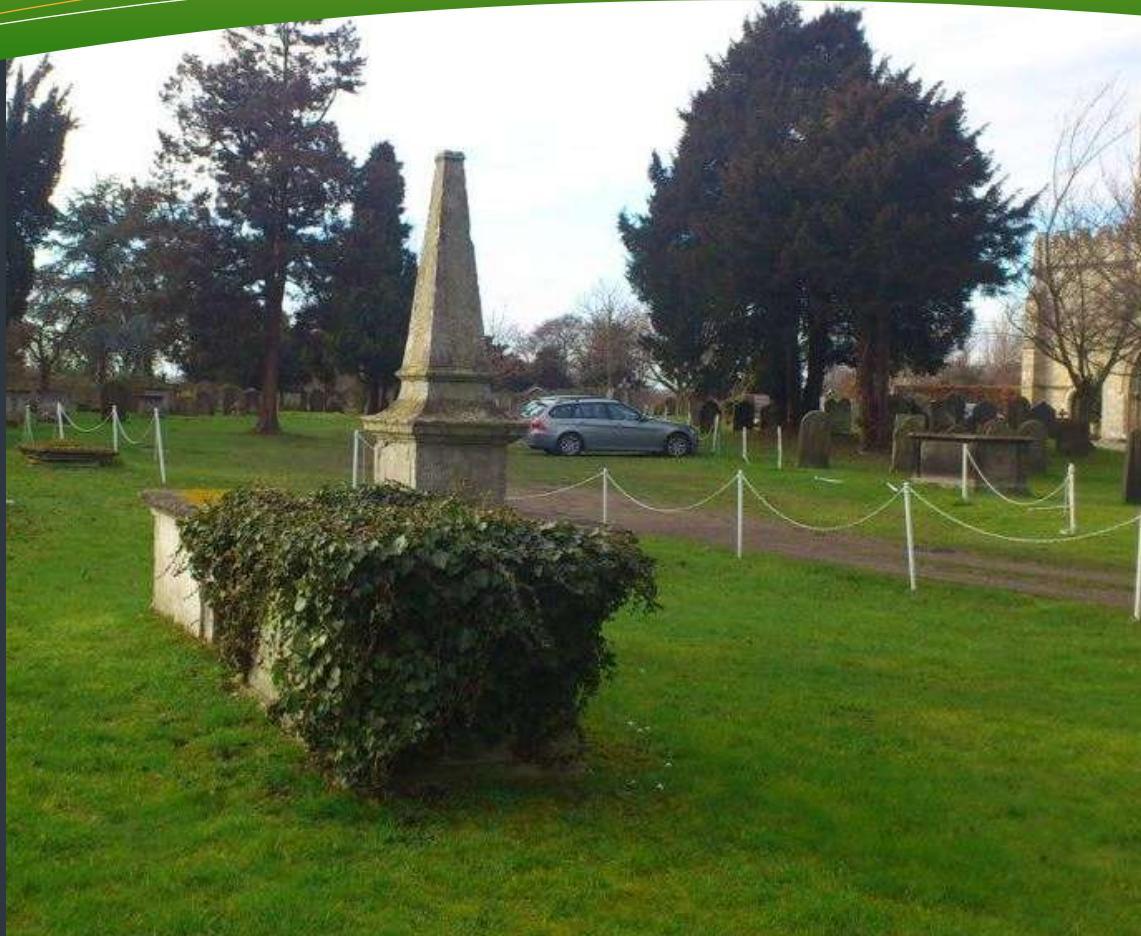
Large cracks, much worn stonework.

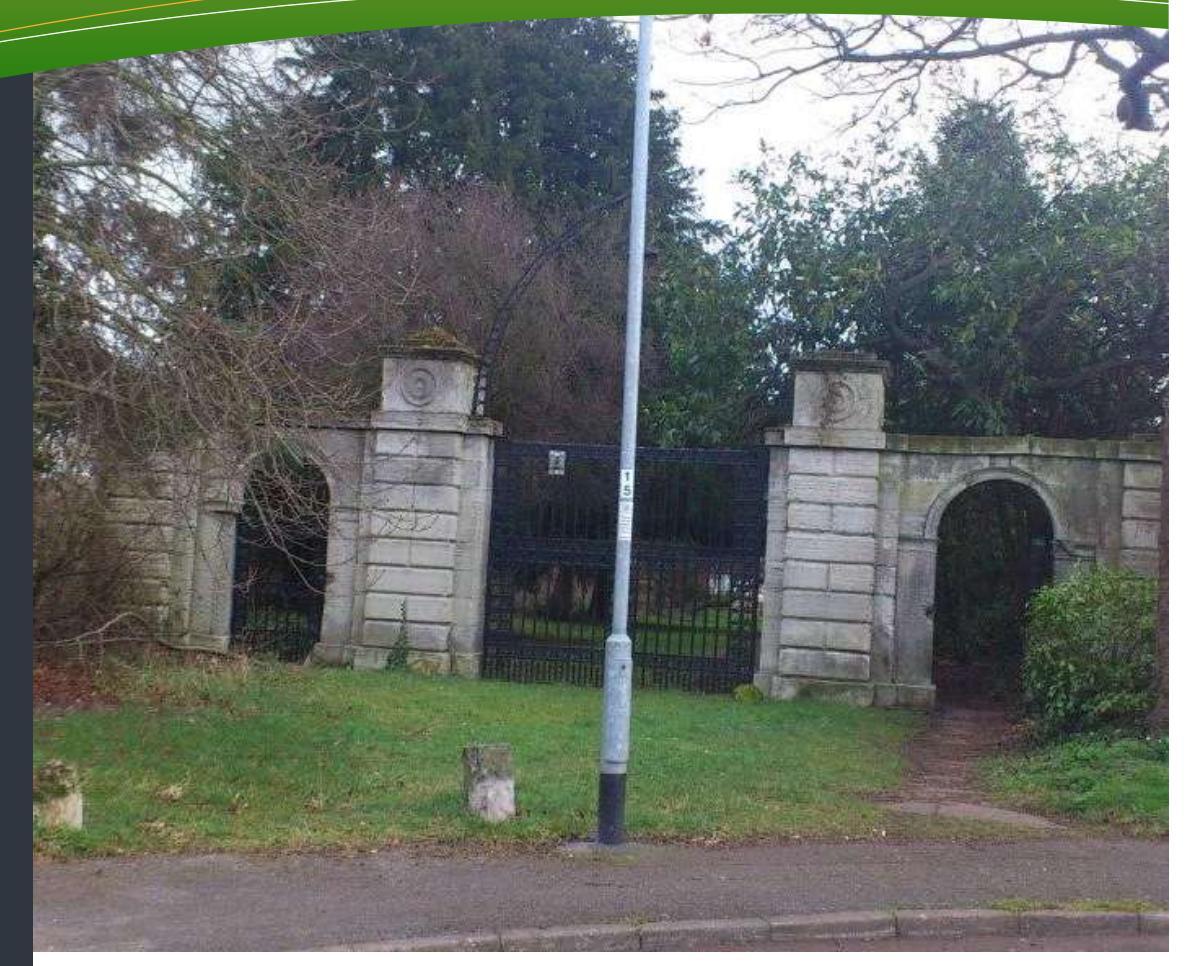
Stone damage around metal mounting joints.

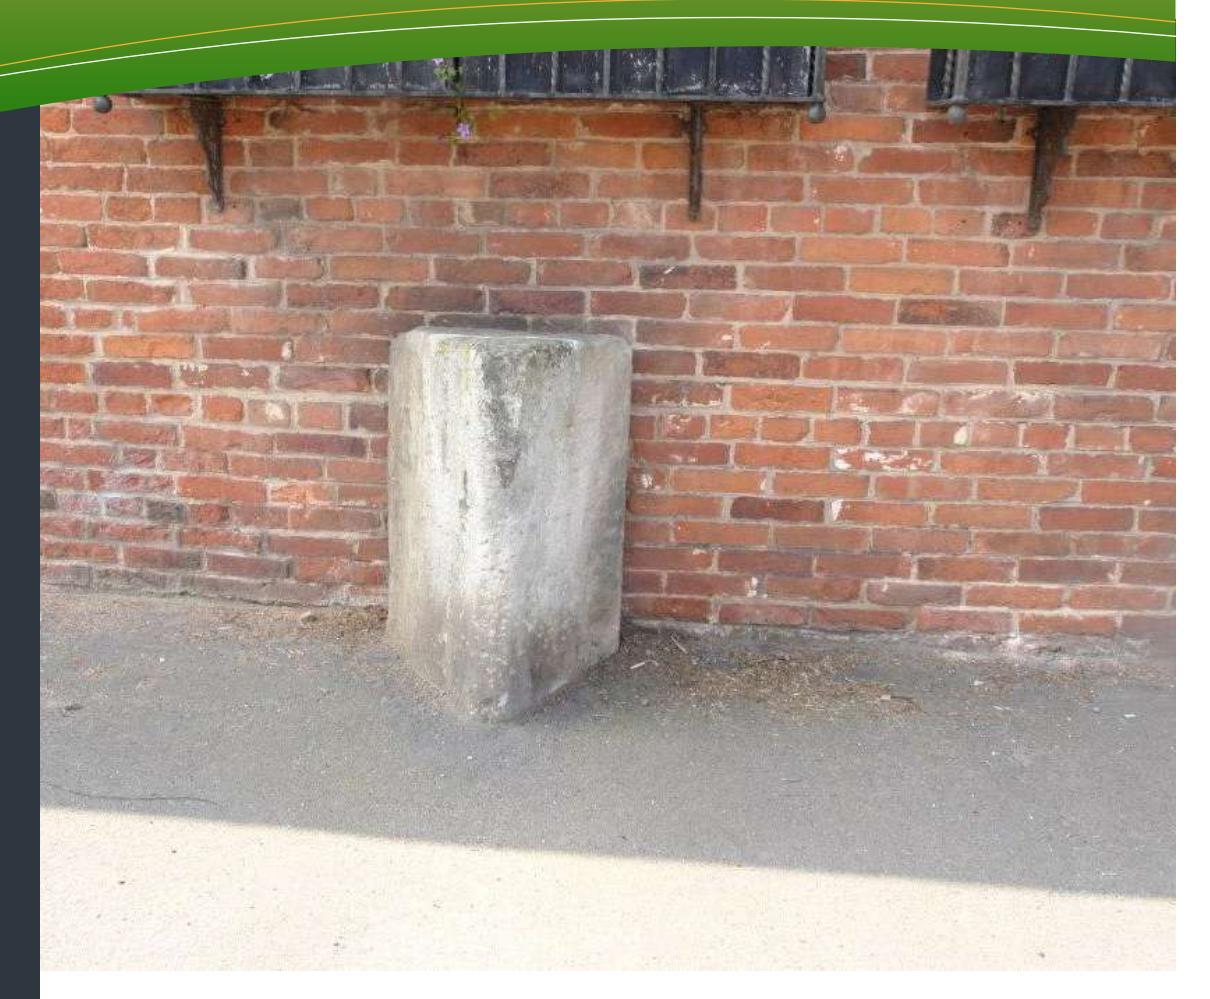
In poor condition, severely eroded.

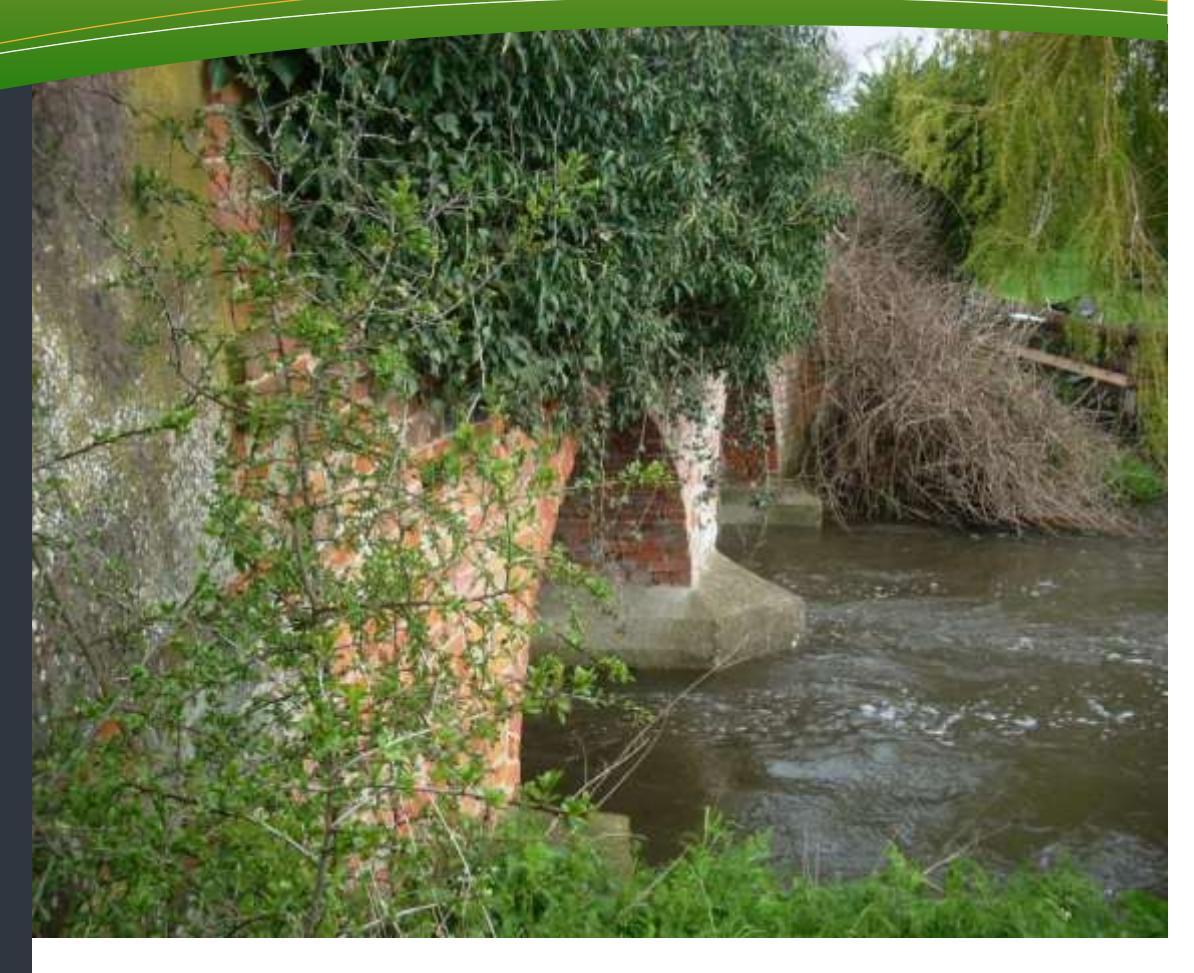
Partial collapse of parapet, fabric fallen into river. Masonry repairs needed. Vegetation is a problem.

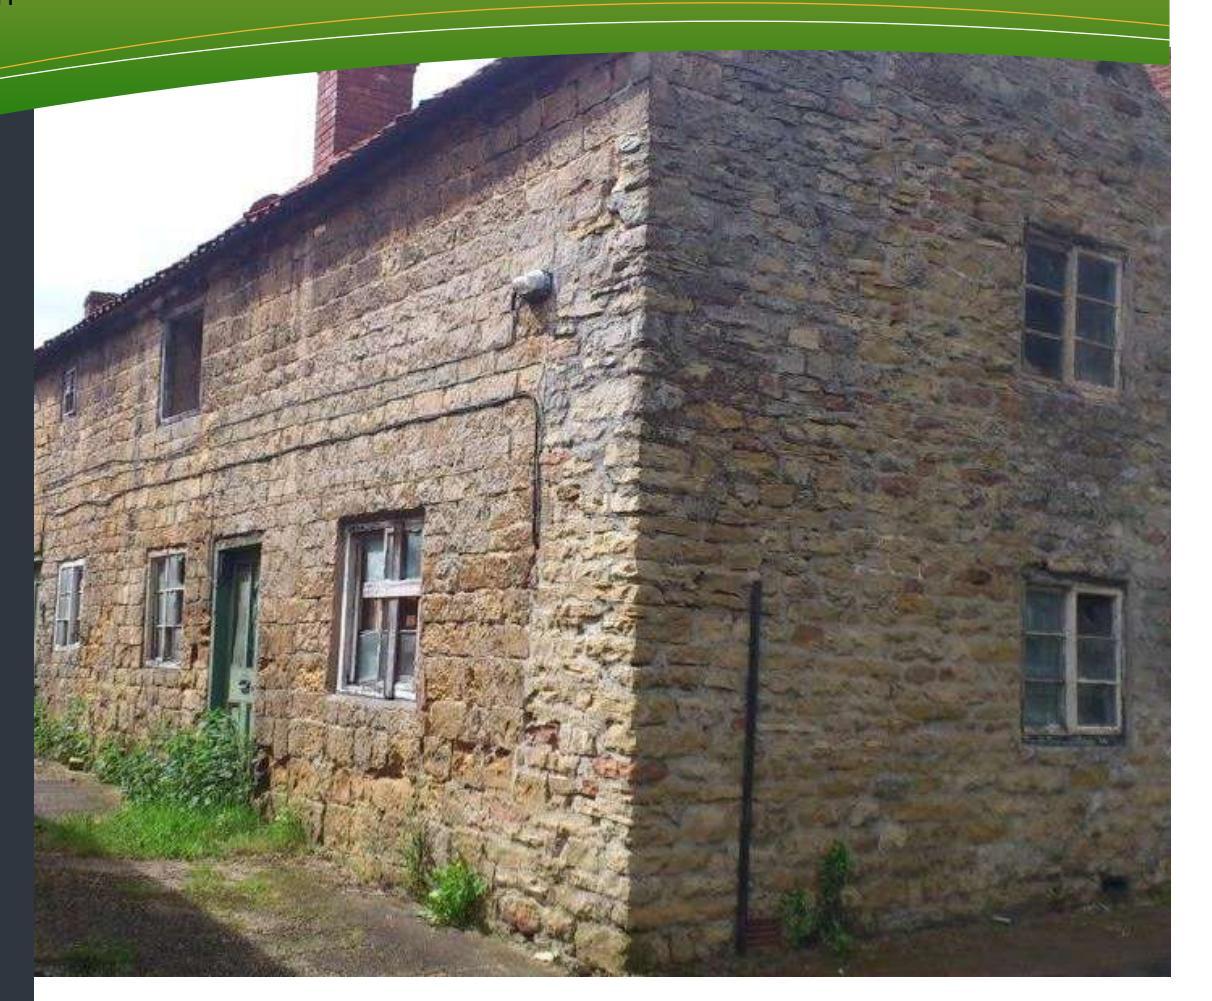
Visible cracks in masonry, notably to external wall in south gable. East wall is bellying near south gable. Missing/slipped roof tiles. Vegetation to ridge and chimney stack at southern end of building. Missing/defective rainwater goods. Stone walls in need of repair/repointing. Pigeon infestation. Water ingress to first floors and signs of deterioration in lathe and plaster/gypsum floors (northern most bay of building). Partially used for storage by adjacent cottage.

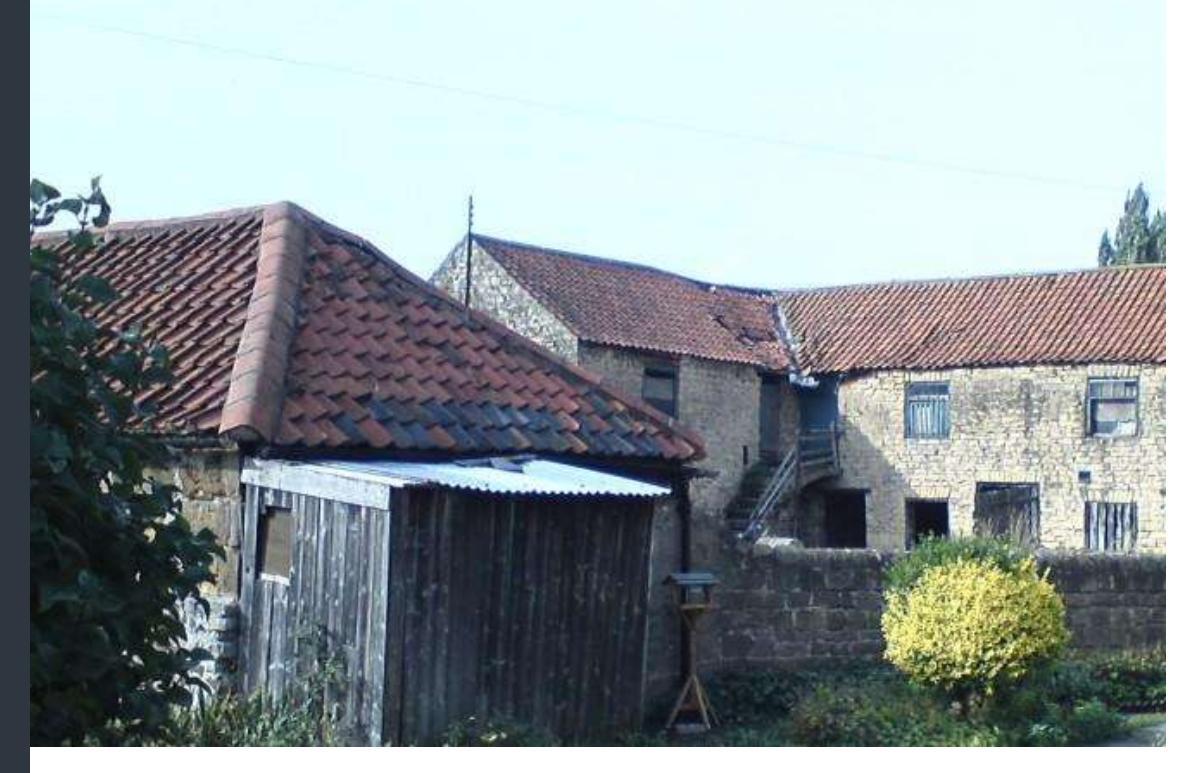
The main barn is showing signs of disrepair with missing tiles and evidence of small scale collapse in the corner of the roof. Much of the guttering is broken, several timber windows and doors untreated or damaged, signs of structural instability.

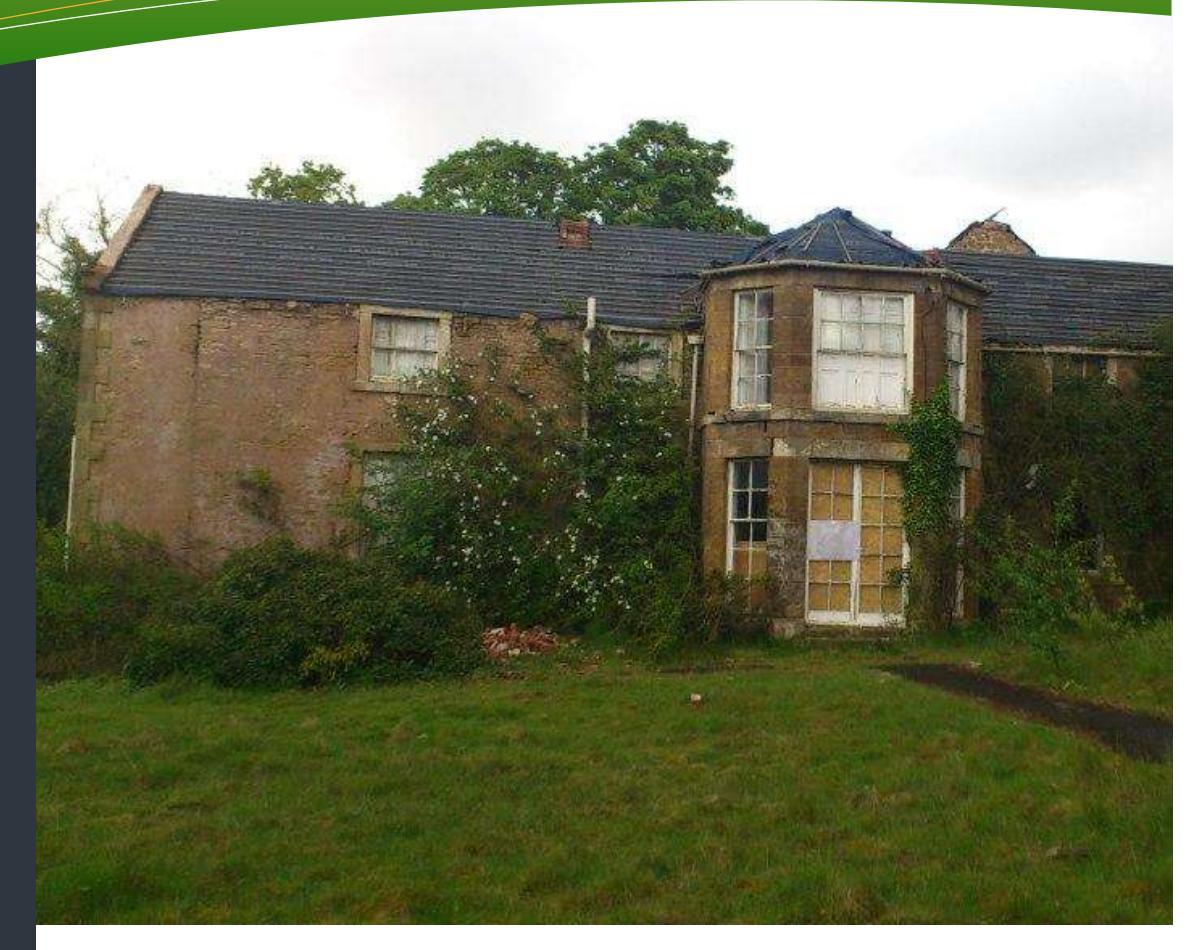
The house has been abandoned and lost its roof which, although temporarily protected, could lead to serious deterioration. The chimneys have collapsed through the roof. Much of the guttering has broken, leading to deterioration of the masonry. Doors are boarded up and windows are shuttered, although many are broken. Vegetation is increasingly becoming a serious problem, particularly on the back wing of the house.

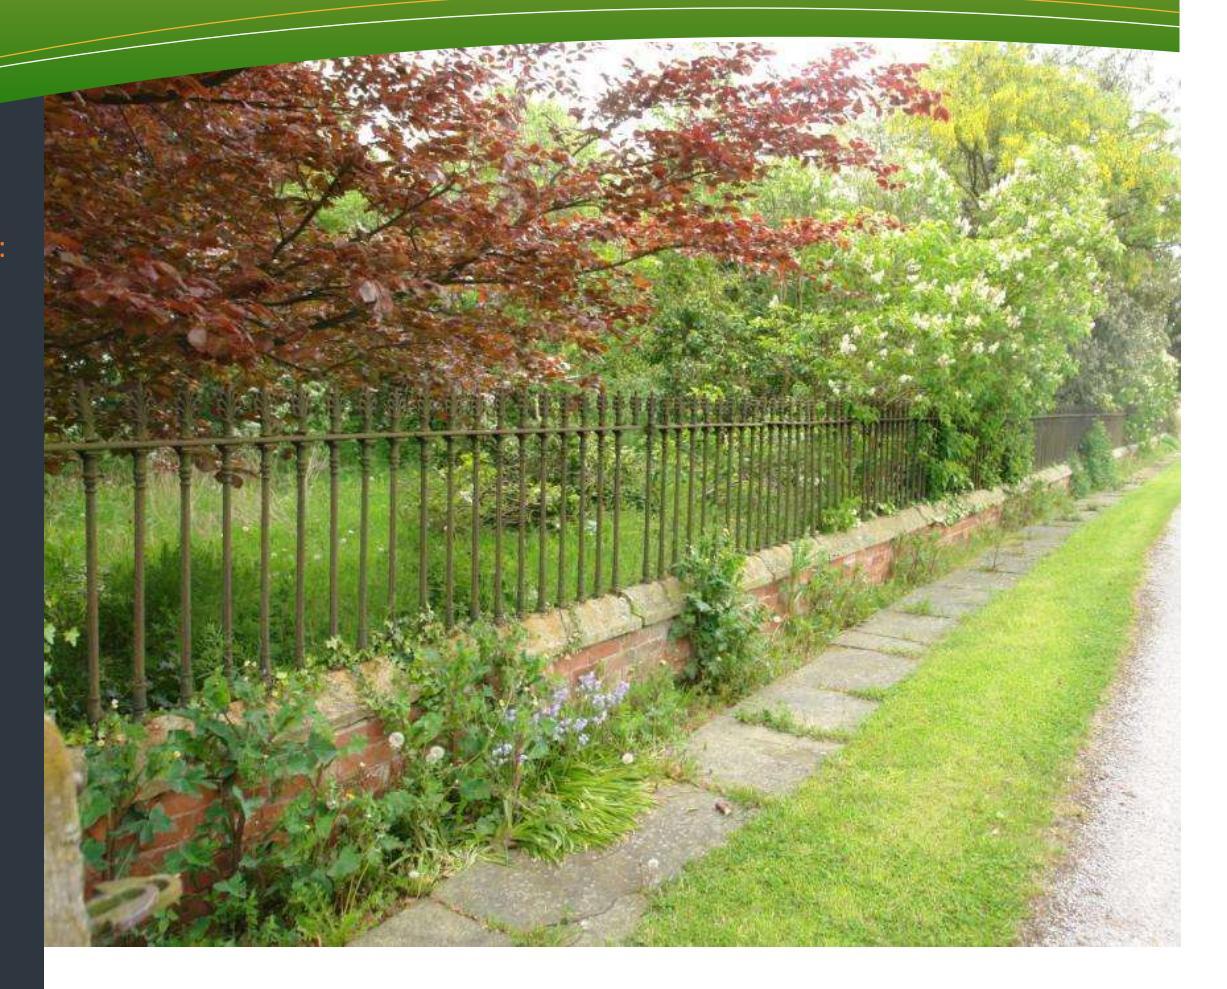
House is occupied but attached wall is considered to be vulnerable. Structurally sound, but lack of maintenance. Small number of individual vertical rails missing. Vegetation is a slight problem.

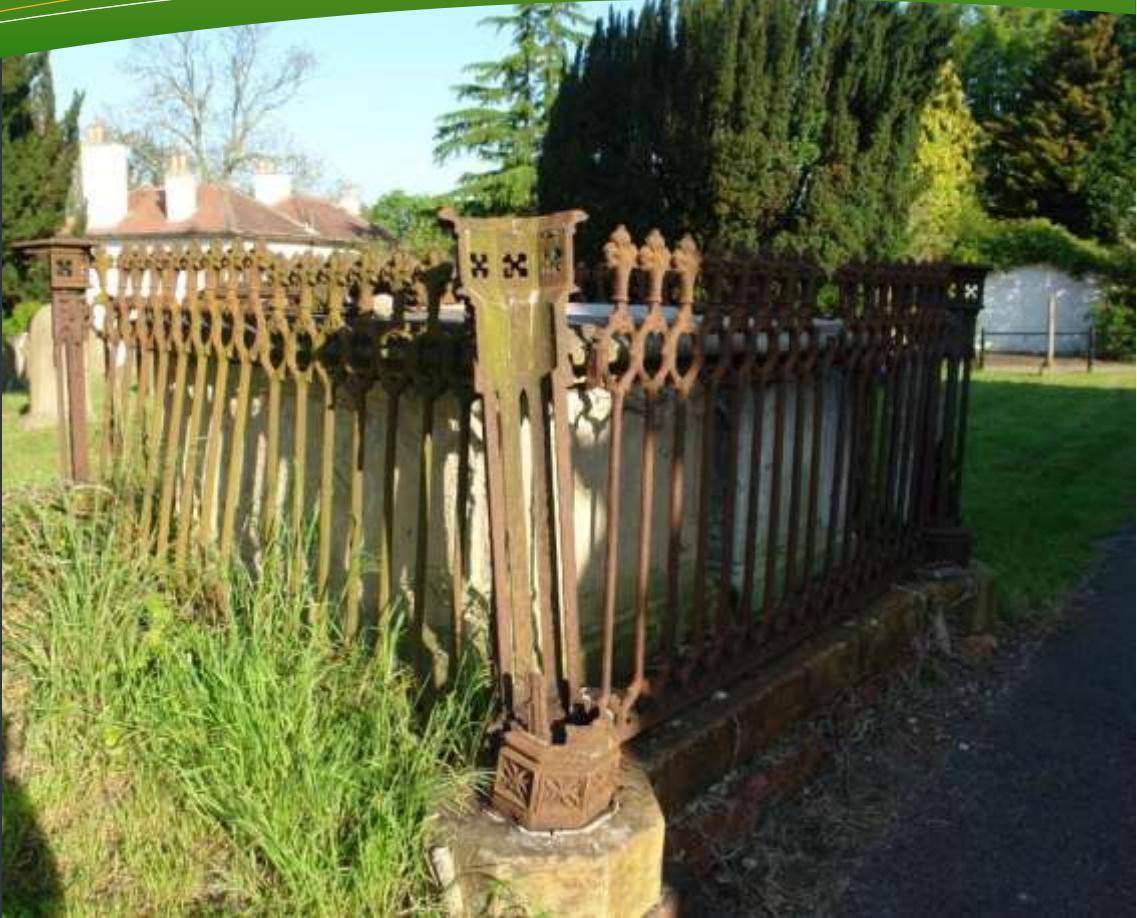
Structural failure, decay and material loss to ornate railings. Loose railings and cresting material amongst foliage and rested on tombs. Erosion to stone work and foliage growing through fabric.

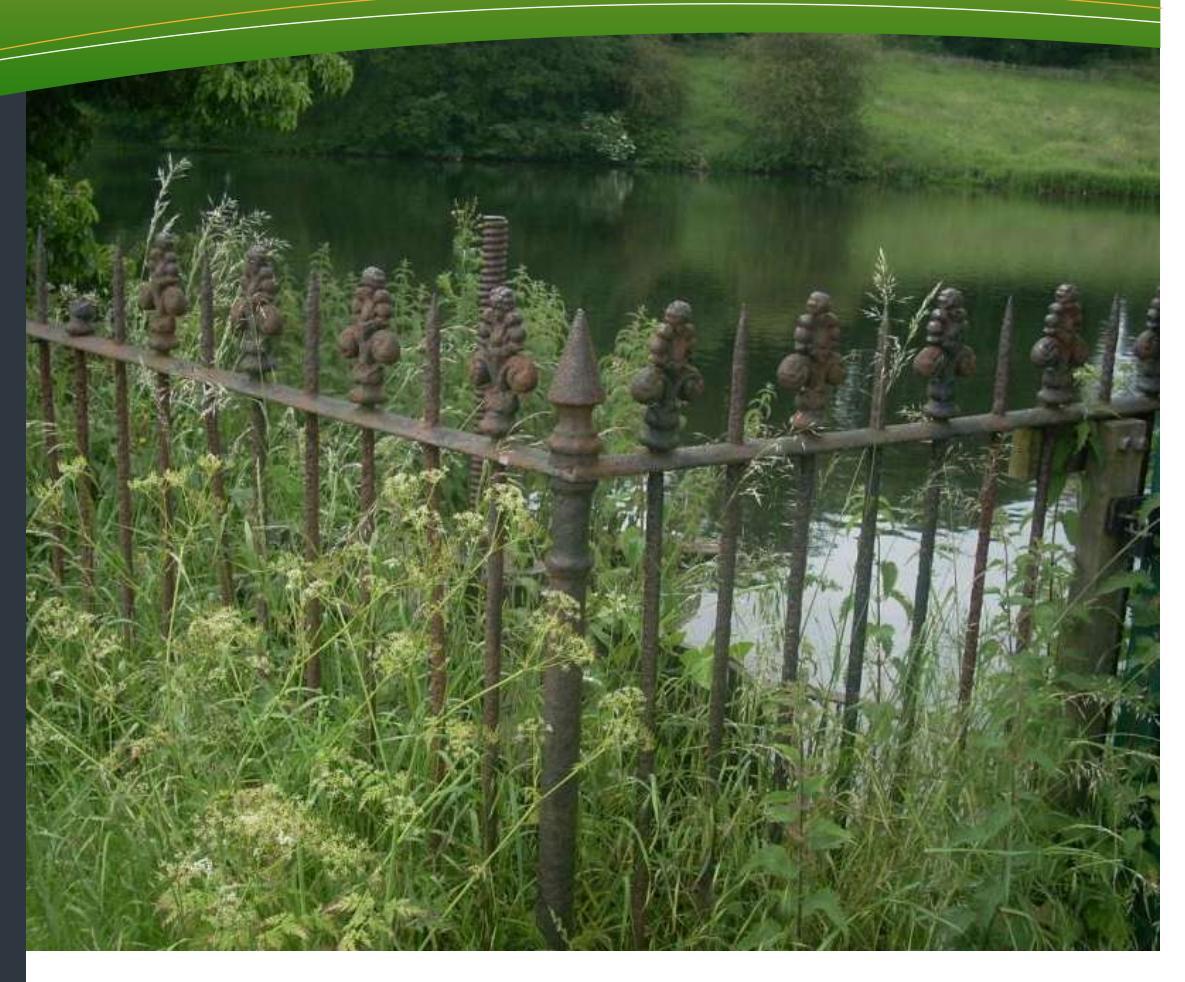
Railings in poor condition and ironwork is corroding. Several finials missing.

Listed Building Consent granted in September 2007 to relocate fish guard and repair sluice (reference: 60/07/00005/L).

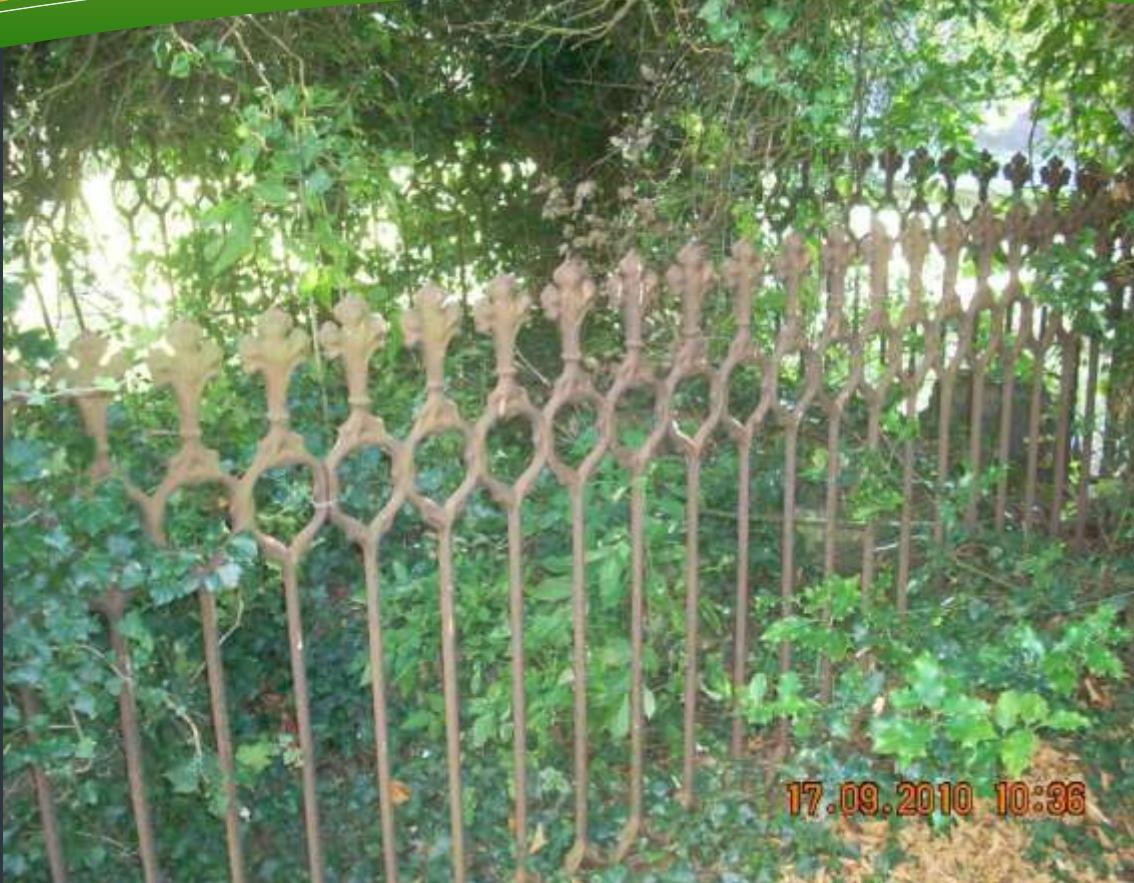
Railings split, ironwork is corroding and finials lying on the ground. Ivy growth on tombs.

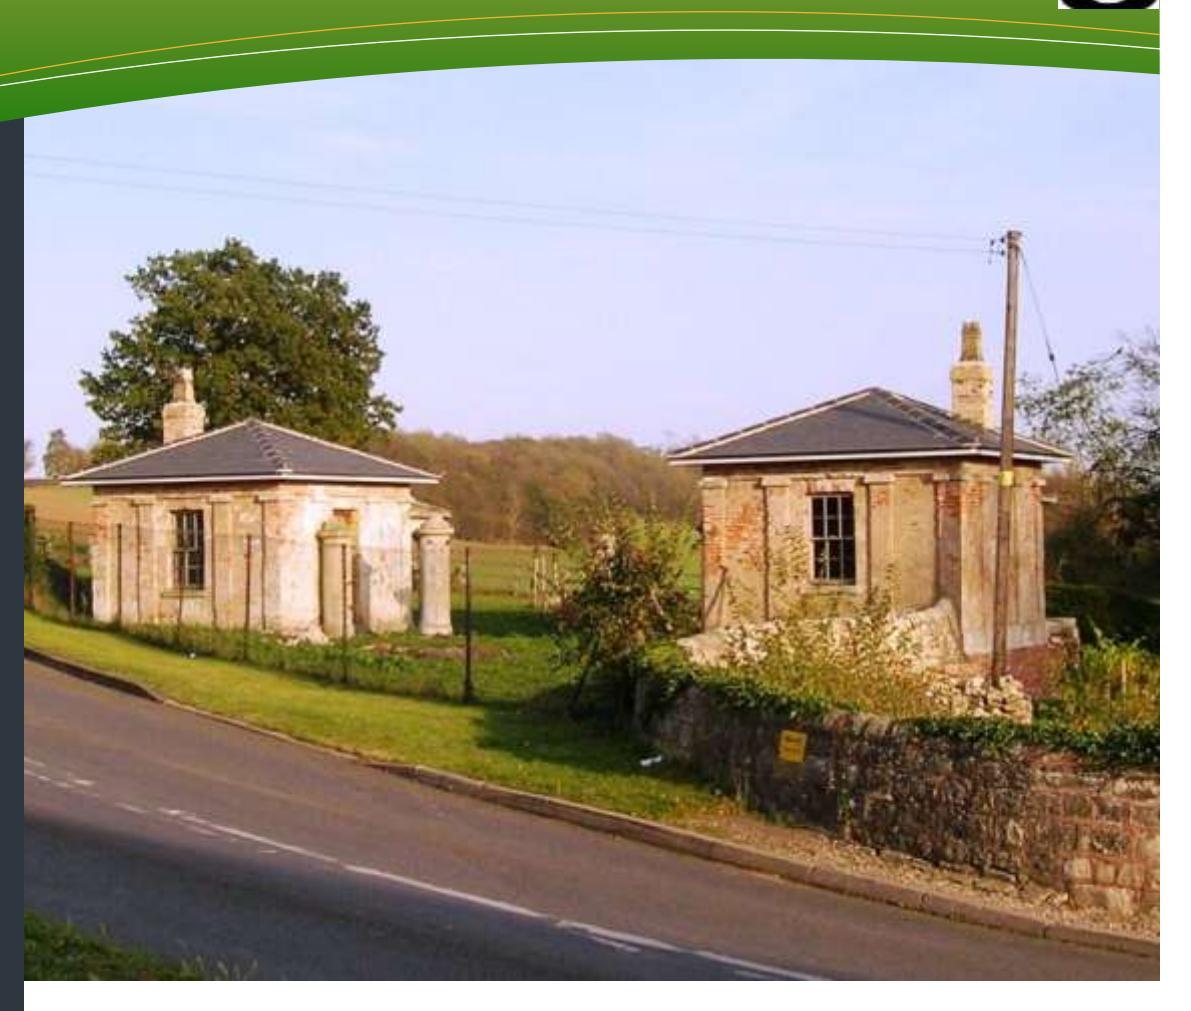
Partially occupied, being used for storage in relation to small holding. Rear portico on south lodge completely lost, north lodge portico in parlous condition. Windows, doors and stucco render in poor condition, but vegetation cleared and roofs fully repaired with Council grant assistance in 2011.
