## Unregistered Park & Garden:

### Hodsock Park

UPG25

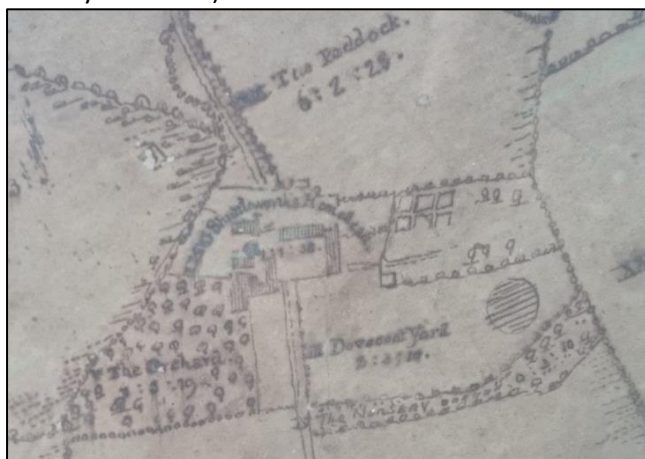
1768 Map of Hodsock Park

The house itself appears to be early-18<sup>th</sup> century in date, with a carved fireplace within the house having the inscription "1703". The earliest map of the site, from 1768, shows the present farmhouse (to the left of the driveway), together with a series of outbuildings including stables and dovecote, with tree plantations, a large pond, orchard and gardens. Most of these outbuildings were demolished/replaced in the 19<sup>th</sup> century and an older part of the house on the rear (probably 17<sup>th</sup> century or earlier) was demolished in the mid-20<sup>th</sup> century.

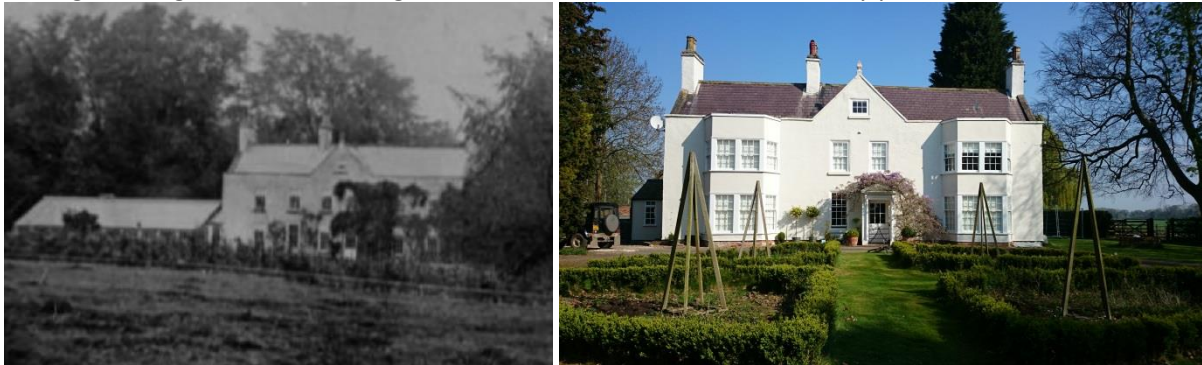
The house, probably being a re-fronting of, or extension to, an earlier house, has a near-symmetrical façade, although with full-height canted bays added in c1910, either side of the central section that has a stone-coped pediment with finial above. The frontage also has timber glazing bar sashes throughout together with a half-glazed timber door within a 19<sup>th</sup> century porch.

*View of Hodsock Park from c1900 and present day.*

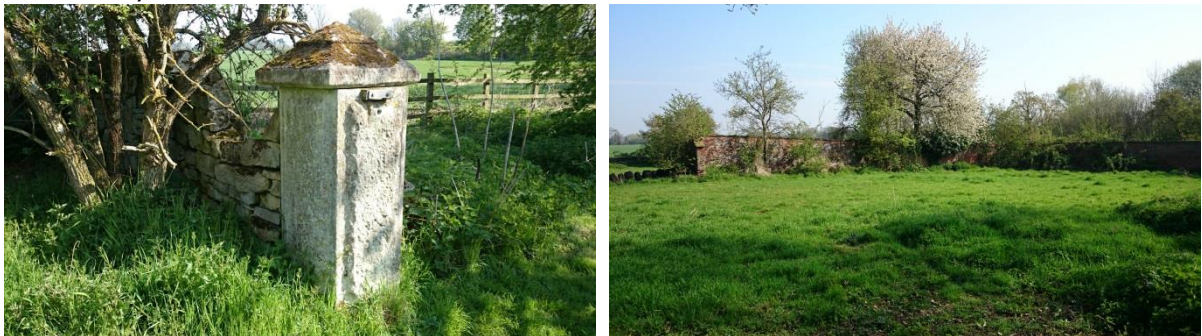
To the east of the house is a walled kitchen garden, dating to the late-18<sup>th</sup>/early-19<sup>th</sup> century, although adjacent to earlier walls (probably part of the gardens shown on the 1768 map). To the north is a series of outbuildings including an 18<sup>th</sup> century stone workshop and an early-19<sup>th</sup> century barn with later-19<sup>th</sup> century additions. Towards the front of the house, the centre of the site is enclosed by a ha-ha with stone wall, together with metal posts. At the front entrance is a large iron gate with similar iron posts. East of the house, adjacent to the kitchen garden, is a spring-fed pond. To the north west of the house is a further spring, although feeding a stone-lined water cistern with early-19<sup>th</sup> century outdoor bath attached (the adjacent field is called “Bath Close” on the 1768 map so it is likely a bath existed at this site in 1768).

*18<sup>th</sup> century wall and pier (left) and late-18<sup>th</sup>/early-19<sup>th</sup> century walled kitchen garden (right)*

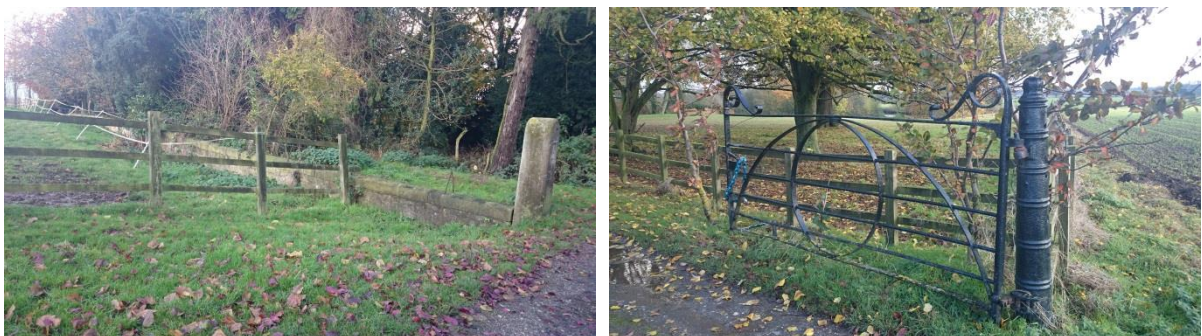
*Ha-ha and iron gate to south of house*

To the south of the ha-ha is a larger area of open parkland, which originally stretched towards the roadway to the south (see 1840 map), although now is limited to the immediate confines of the house. The wider farmland is clearly defined on the 1768 map, produced for the owner of the site at the time, Mr Shuttleworth.

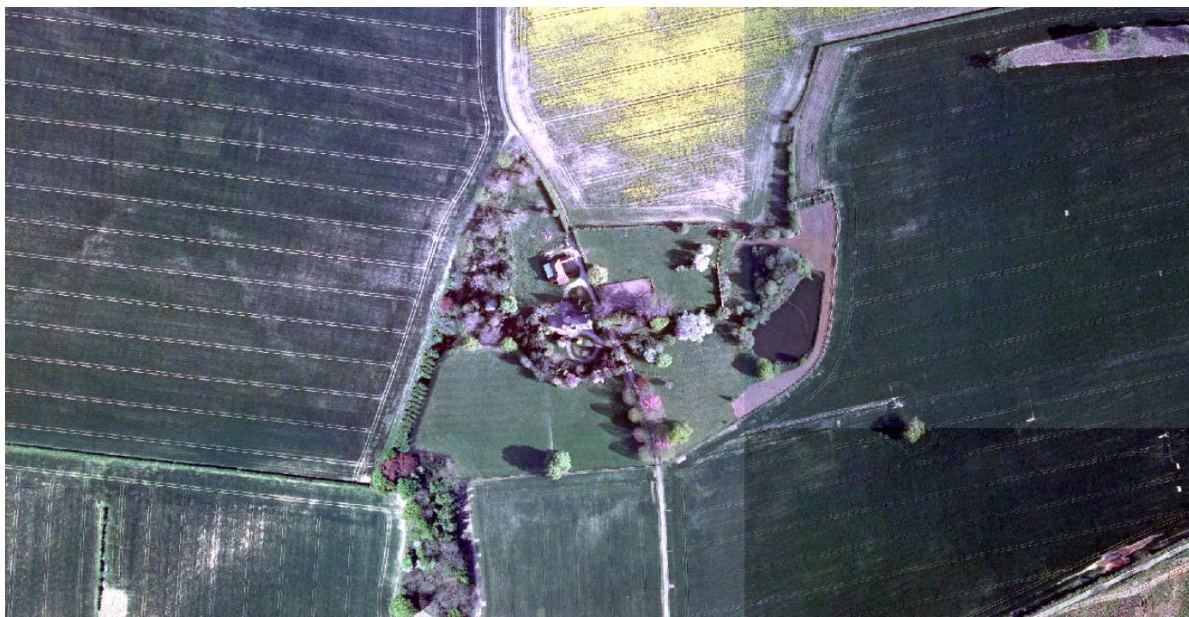
Aerial photograph of Hodsock Park, taken 2007 (source: Bassetlaw District Council)
