## **Retford**

**Regeneration Workshop  
10 December 2014**

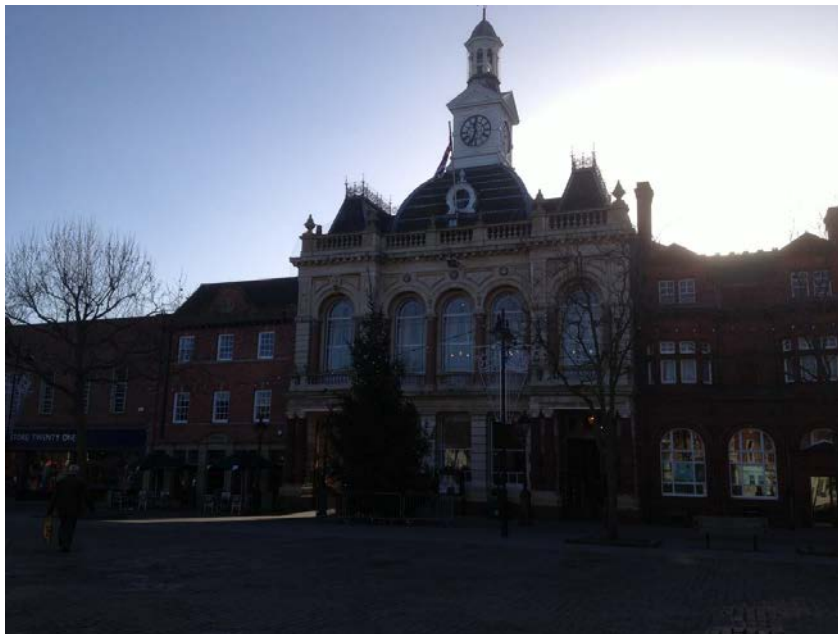
*Fig. 2 Town Hall, Market Place © PRT*

There are a number of examples within the town centre where consideration of the historic environment has proven successful. For instance, the Town Hall remains in use and the internal fabric of the building has been preserved (Fig. 2). As well, a modern residential development beyond the river has respected the surrounding historic landscape through the choice of materials and scale.

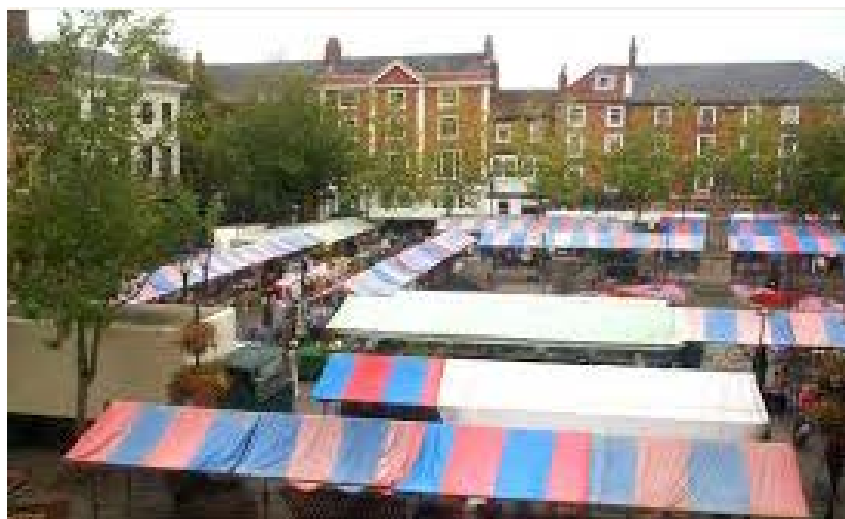
*Fig. 3 Market Square on market day*

Retford has benefitted through funding from the European Regional Development Fund and BDC, which has enabled significant improvements to the elegant main square (Fig. 3), and which now has high quality paving and lighting and a good sense of public realm. It won a Civic Trust Award in 2008. As the Civic Trust's Heritage Trail says 'on market days it erupts into a hurly burly of buying and selling in the long tradition of Retford fairs and markets'.

Public spaces such as this give Retford a highly distinctive historic character. The townscape would benefit from these efforts being replicated on the surrounding streets.

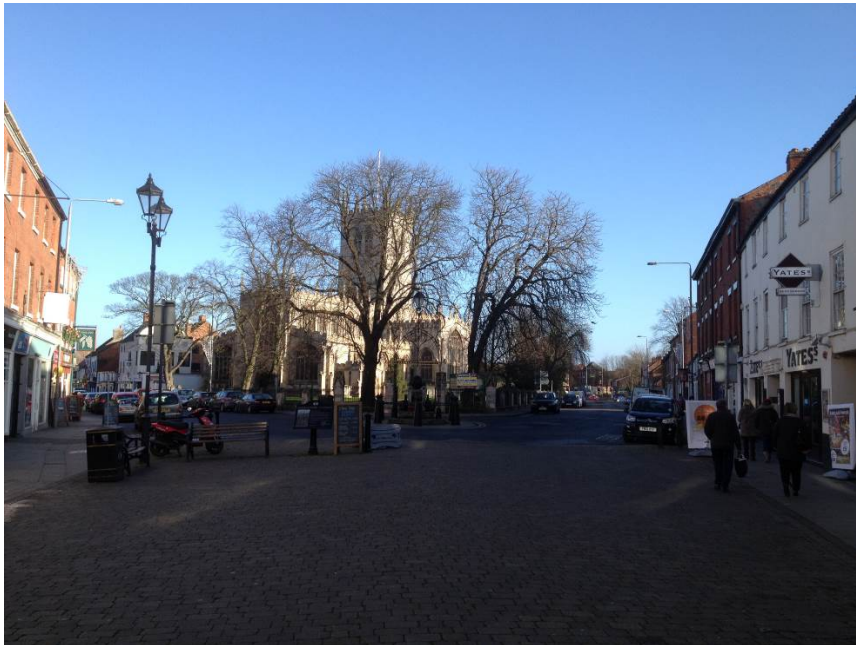
*Fig. 4 Market Place and Parish Church © PRT*

The Market Place, on the approach to the Parish Church (Fig. 4), is another key space but adopting the same palette of materials would help to better link Market Square with Market Place and lead the pedestrian through a harmonious townscape. At present the cobbled street surfacing carries the traditional character

through towards one of the most important buildings, but it does not continue all the way. The character would be enhanced if it continued across Cannon Square up to the entrance to the churchyard rather than stopping at the road edge and suddenly becoming more urban and car-orientated.

It is essential that the long view through to the church is maintained (Fig. 4), including the trees.

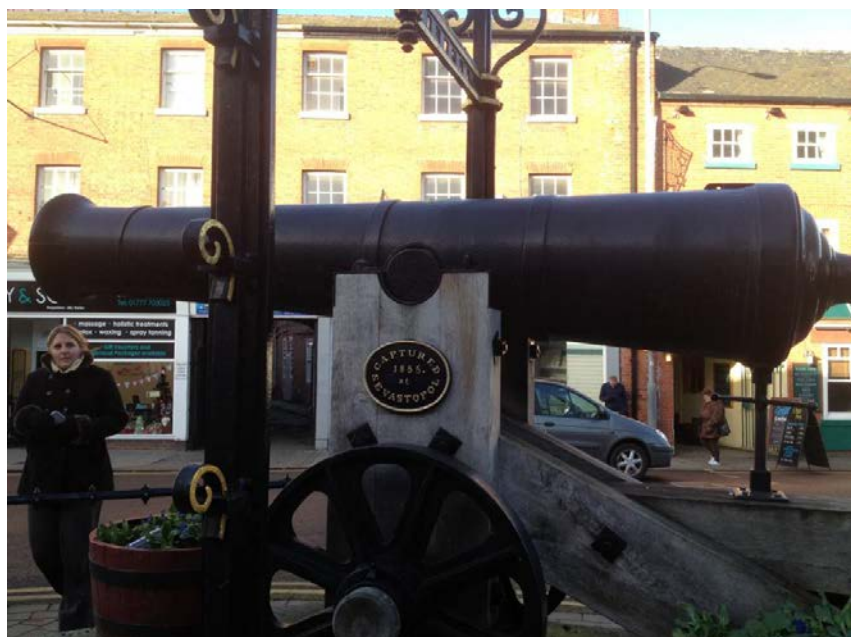
*Fig. 5 Cannon Square © PRT*

In Cannon Square the displayed cannon (captured at Sebastopol in 1855) is surrounded by bollards and double-yellow lines though it is a key townscape feature illustrating an aspect of the town's history (Fig. 5).

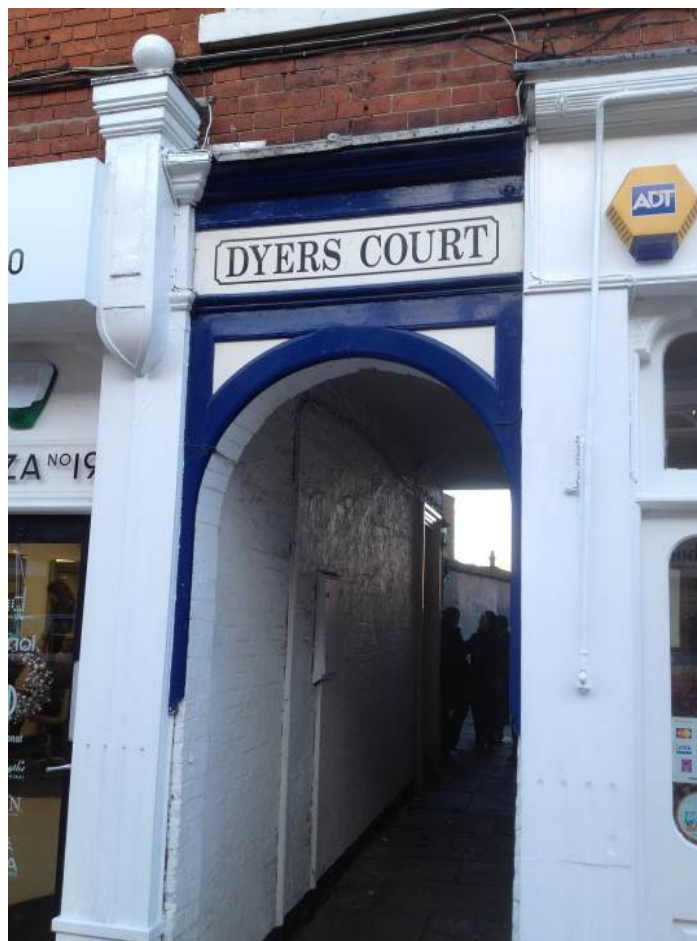
*Fig. 10 Dyers Court © PRT*

The town plan is characterised by a number of connecting alleys and passageways and it is essential that these are retained and enhanced. They are immediately illustrative of the town's historic origins but also offer good connectivity between different streets. Covered passageways need to feel safe and alive not dark and forbidding.

One notable example of this town plan characteristic and of recent work to enhance it is Dyers Court, off Grove Street (Fig. 10).

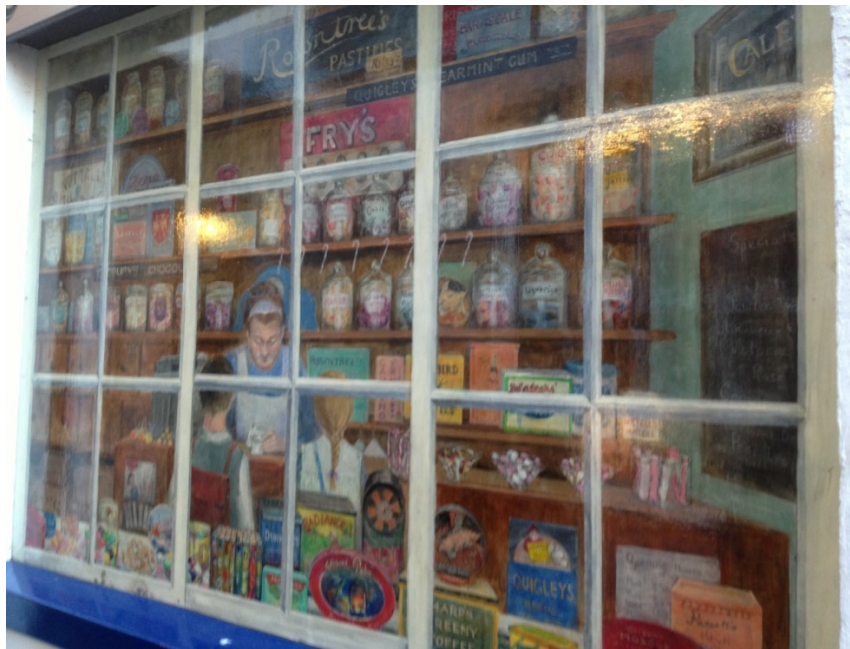
*Fig. 11 Shop window in Dyers Court © PRT*

Here the main shop window facing onto the passageway has been painted to appear occupied (Fig.11). The image created of a traditional Victorian / Edwardian shop is impressively achieved and the references to local people adds further interest. A similar style mural is also at the rear of Dyers Court on the wall of the former laundry (Fig. 12).

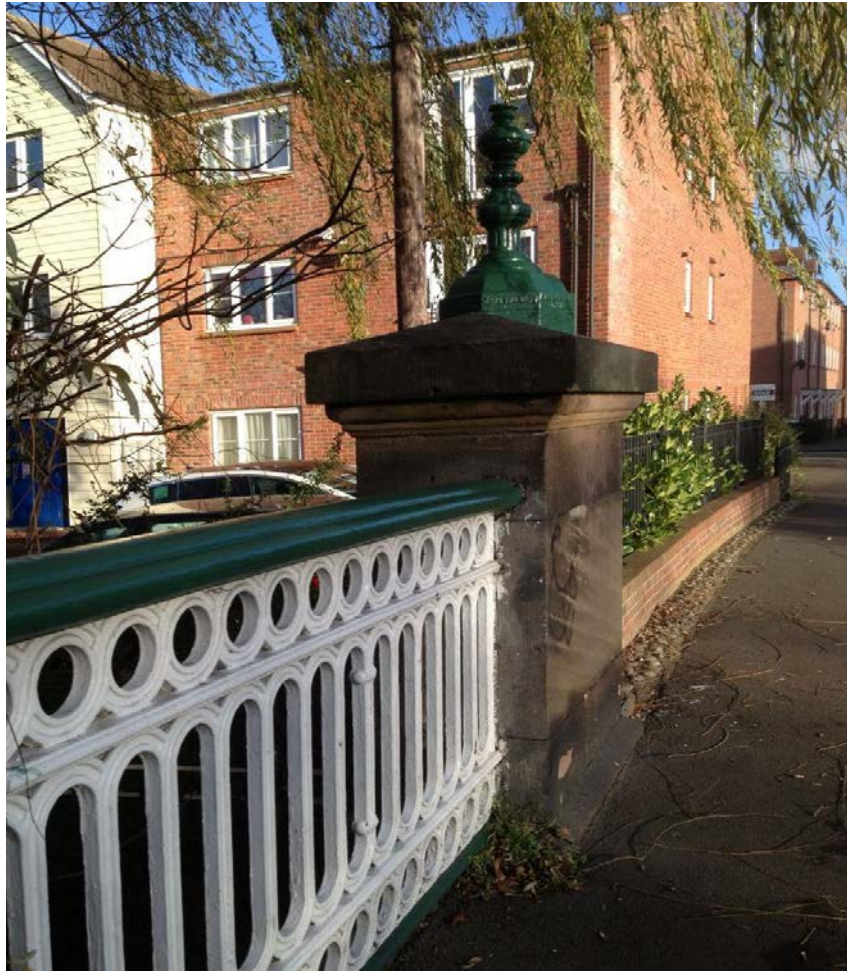
*Fig. 15 Albert Road Bridge over River Idle © PRT*

The River Idle and the Chesterfield Canal are both key arteries for the town and views of, and along both the river and the canal, must be retained (Figs. 13 and 14). There are also two fine road bridges over the river, the one on Albert Road is dated 1892 (Fig. 15).

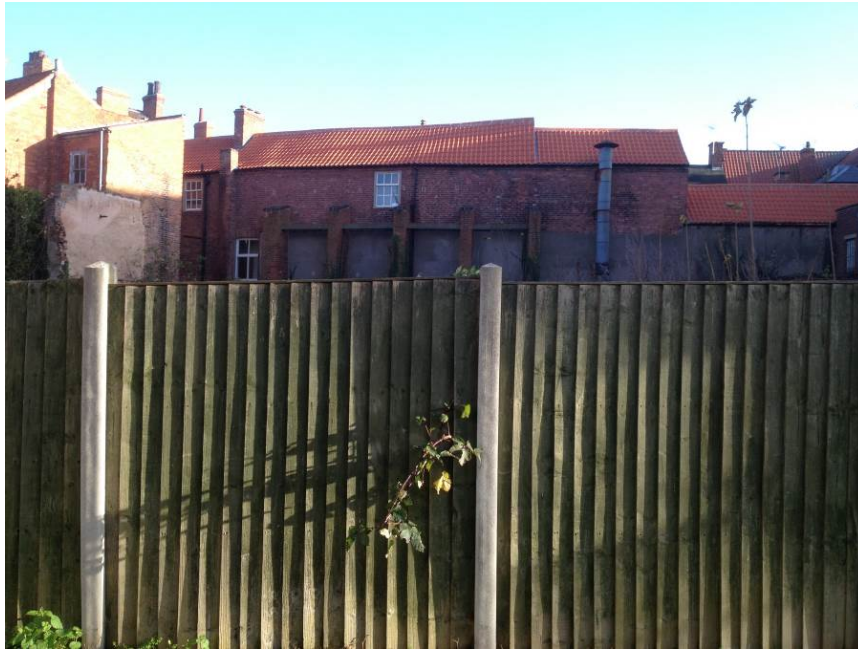
*Fig. 16 Development site near Market Square and Bridgegate © PRT*

The development site illustrated in Fig. 16 is near the Bridgegate Centre, close to the main square. Any new build here needs to respect the proximity to historic buildings in scale and materials but it should be noted has potential to improve on the current abandoned appearance of the area. The new development of shops and residential immediately to the west of this site is of unsatisfactory design and should not be seen as a model for the proposed development opposite. The shop fronts are clumsily detailed and the mansard inspired roof appears out of character.

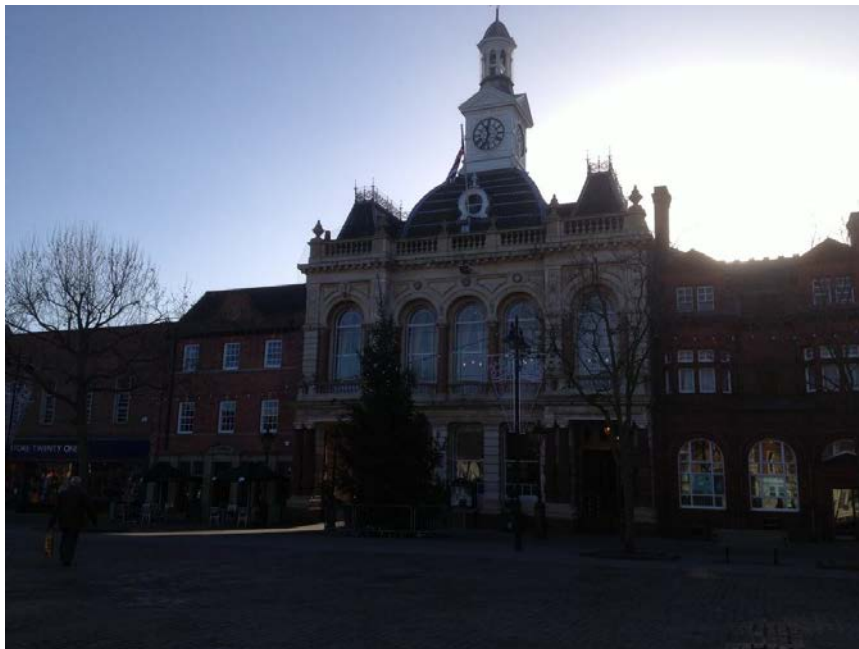
*Fig. 17 Retford Town Hall © PRT*

Foremost amongst the public buildings is the Town Hall, which fortunately is still used for the purpose for which it was built. In an age when local authorities around the country are moving out of their historic town halls and indeed away from their town centres altogether BDC is to be commended for continuing to care for this key building. It was built in 1868 by Bellamy and Hay architects of Lincoln and its façade has definite French Renaissance influence. Internally it retains a fine Ballroom and Council Chamber as well as its grand imperial staircase.

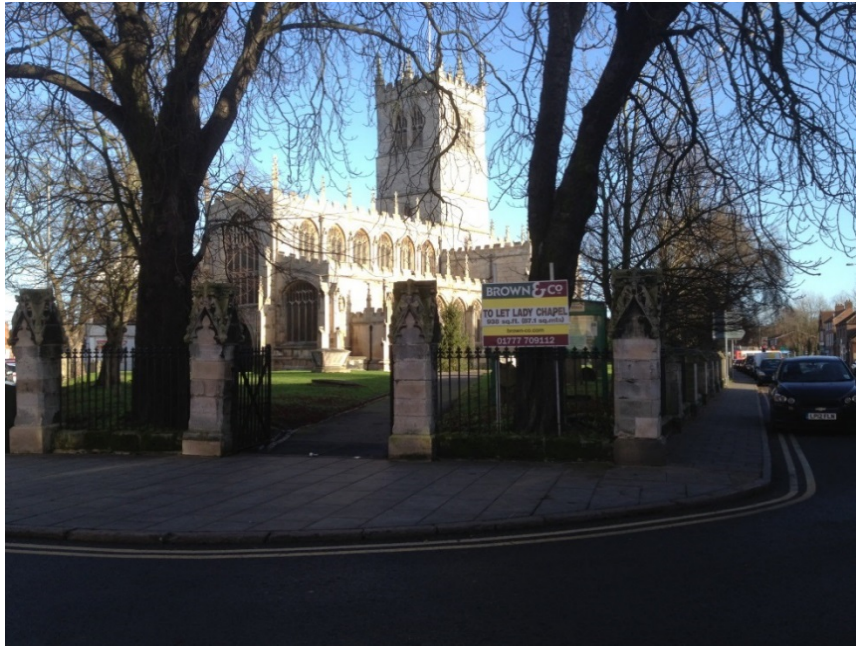
*Fig. 18 St Swithun's East Retford © PRT*

The Parish Church (Fig. 18) was founded in 12<sup>th</sup> century although the primary character of the church today is Victorian. It features in the majority of views into, and through, Retford. It was interesting to note that the Parish Church is seeking to let the Lady Chapel – an unusual move but extra income is needed to contribute to the annual maintenance costs.

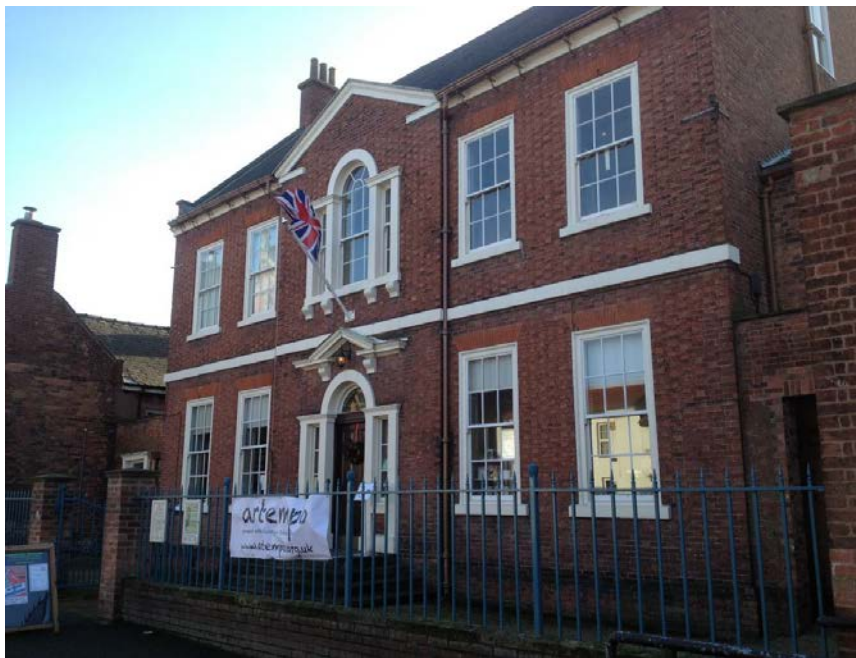
*Fig. 19 Retford Museum © PRT*

Amcott House, one of Retford's finest townhouses, is now the Museum and retains its symmetrical Georgian frontage, c.1780 (Fig. 19). For the sake of the interior detail it is important this remains the museum and is not closed to make local authority savings.

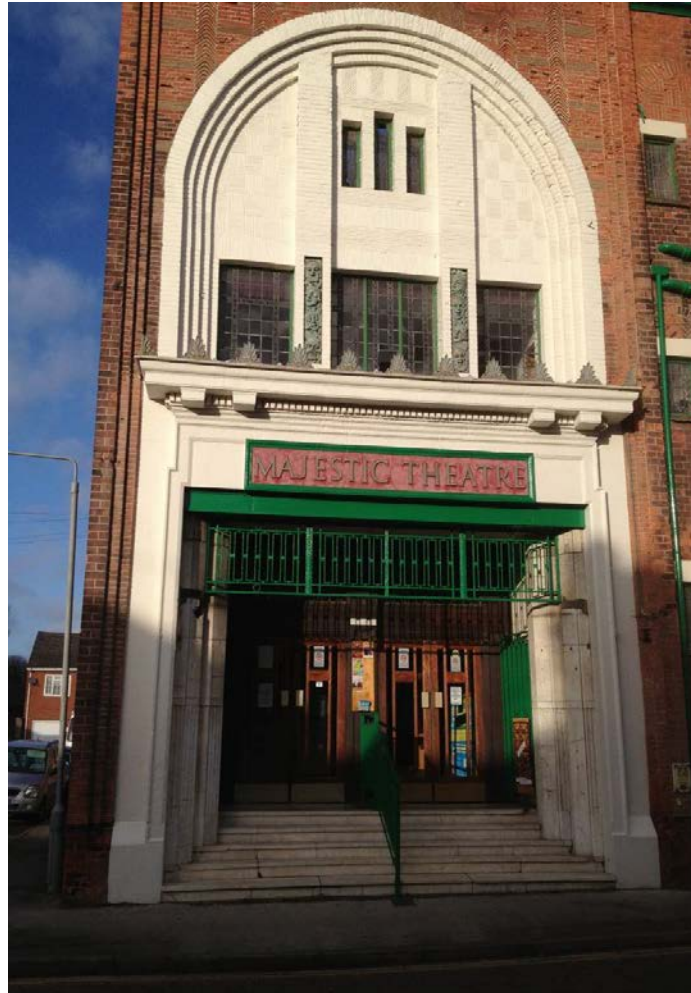
*Fig 20. Majestic Theatre © PRT*

The Majestic Theatre is somewhat hidden in the townscape but its façade on Coronation Street is a remarkable piece of Art Deco architecture, designed in 1925 by Alfred Thraves of Nottingham (Fig. 20).

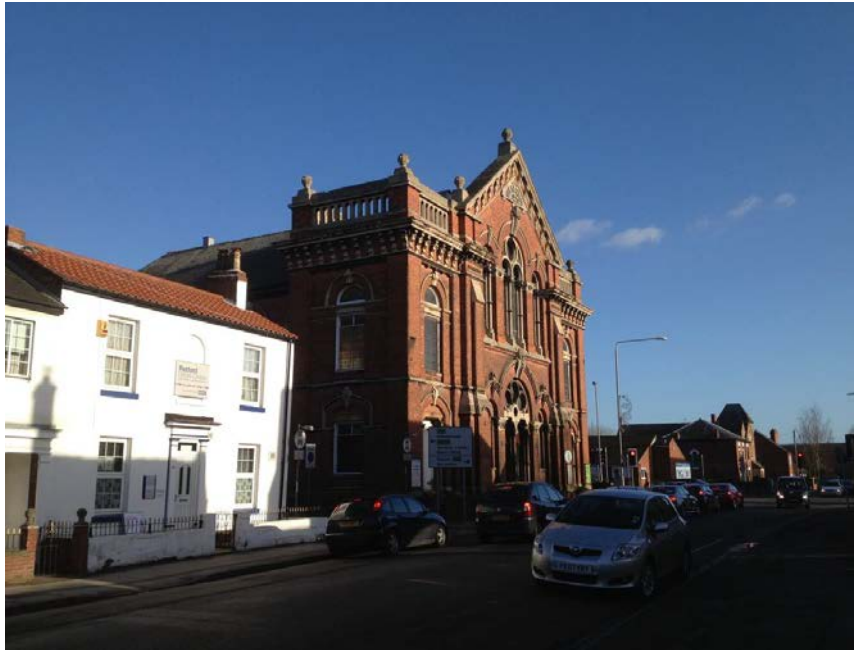
*Fig 21. Wesleyan Methodist Church, Grove Street © PRT*

Wesleyan Methodist Church built in 1880 provides an end stop to this key street and as such makes an important contribution to the townscape. All efforts should be made to ensure it remains in use and if necessary develops appropriate ancillary uses to support viability.

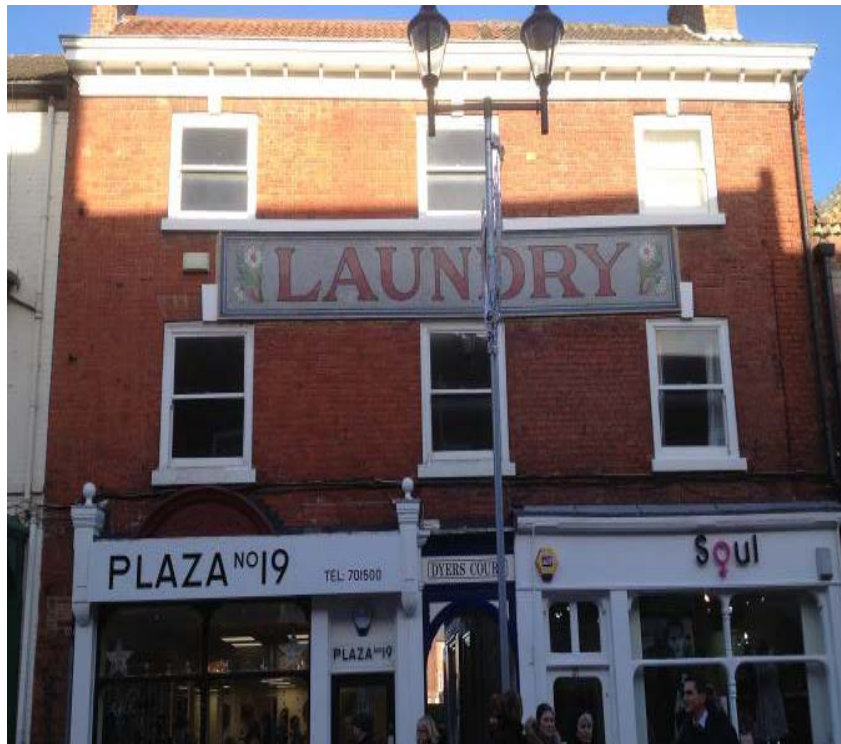
*Fig 22. Former Laundry building, Grove Street © PRT*

One example is on Grove Street (Fig. 22). The building has changed its use but its original function is clear from the distinctive lettered panel on the front elevation. This is essential historical evidence told through the townscape and must be retained.

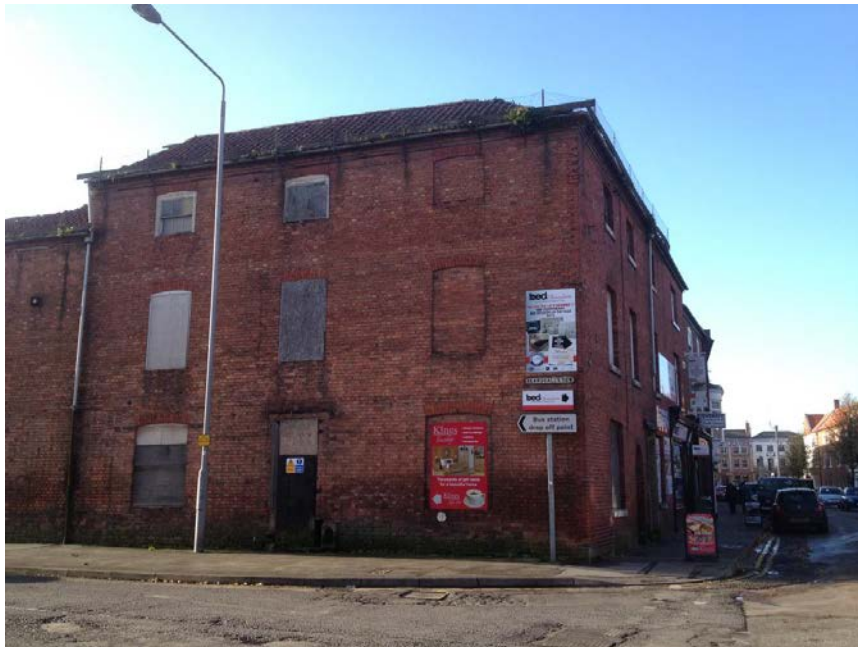
*Fig. 23     26 & 28 Grove Street on corner of Beardsall's Row © PRT*

This is a critical building in the townscape forming the corner of one of the main streets, the building itself is still capable of restoration and has Listed Building Consent for residential and retail conversion. The permission unfortunately has not been implemented. It is said that the difficulty with residential conversion is that it is too large for current demand for single properties and subdivision is necessarily restricted by the need to retain the original staircase which potentially impacts on the viability of refurbishment. On the other hand the need for full subdivision would not arise in, for example, an office conversion, and this should be considered in more detail. The building may have other viable uses.

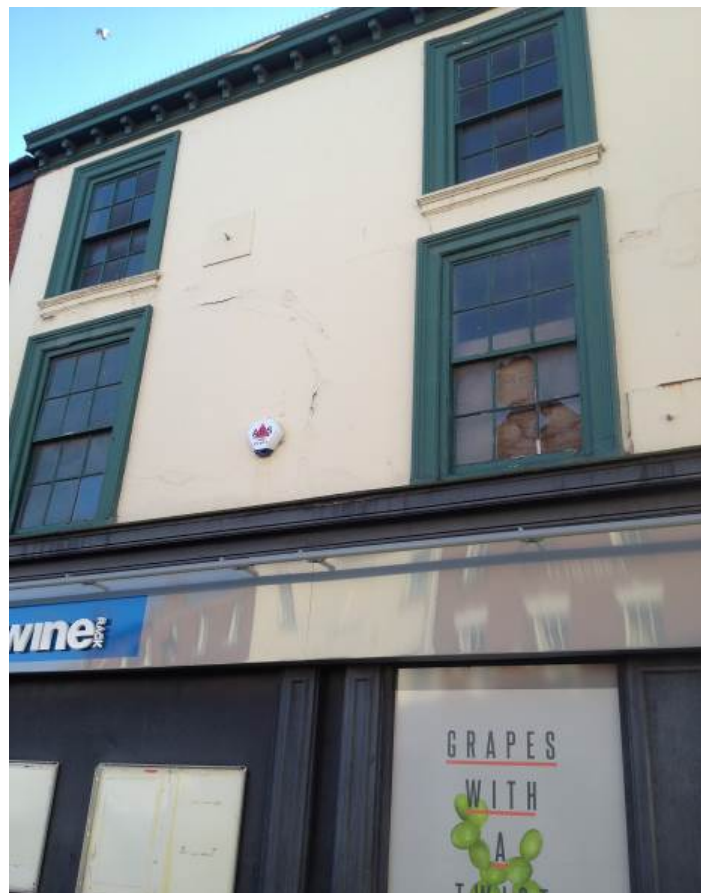
*Fig. 24 Market Square (E side), building at risk © PRT*

This building on Market Square / Market Place is at risk because the upper floors have been long abandoned and broken window panes mean the building is not wind and weather tight. Its appearance highlights its emptiness and therefore puts the building at risk of vandalism. Although the ground floor has been altered the upper floors retain their Georgian sash windows and moulded architraves.

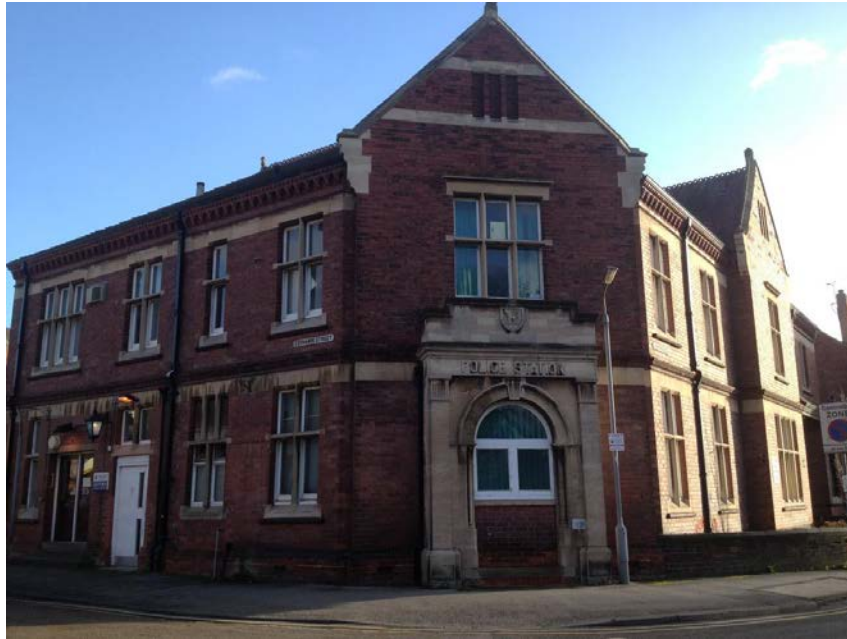
*Fig. 25 Retford Police Station © PRT*

The large police station is architecturally distinctive, intact, and is a prominent building forming the corner of Chancery Lane and Exchange Street (Fig. 25). As is it a positive building within the Conservation Area, there is a presumption for its retention.

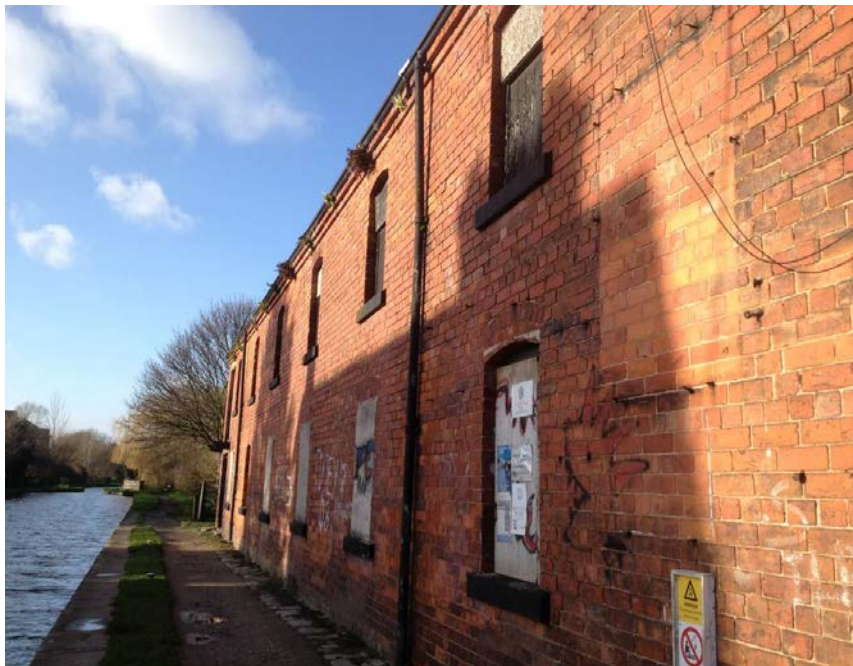
*Fig 26. Former Canal Warehouse at Retford Town Lock © PRT*

The canal warehouse is another empty building of significance to the town's heritage (Fig. 26). It was built in 1882 by the Manchester, Sheffield and Lincolnshire Railway Company. The site had planning permission for conversion to six dwellings but there is no sign this has started and so the building remains at risk.

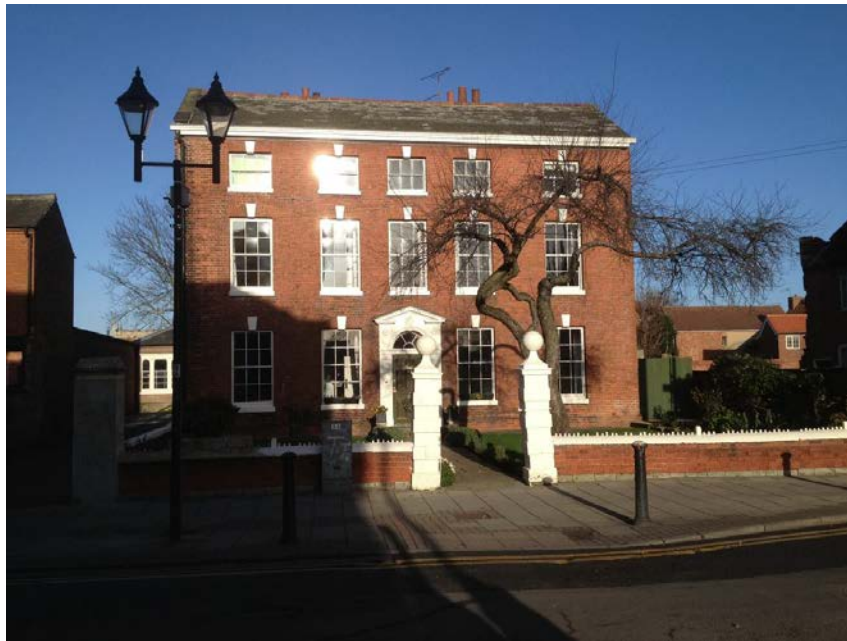
*Fig 27. Georgian house on Grove Street © PRT*

One example is the mid-18<sup>th</sup> century Poplar House on Grove Street directly opposite the building at risk on the corner of Beardsall's Row (Fig. 27). Here the three-storey house has been faithfully repaired and remains in use as a single dwelling.

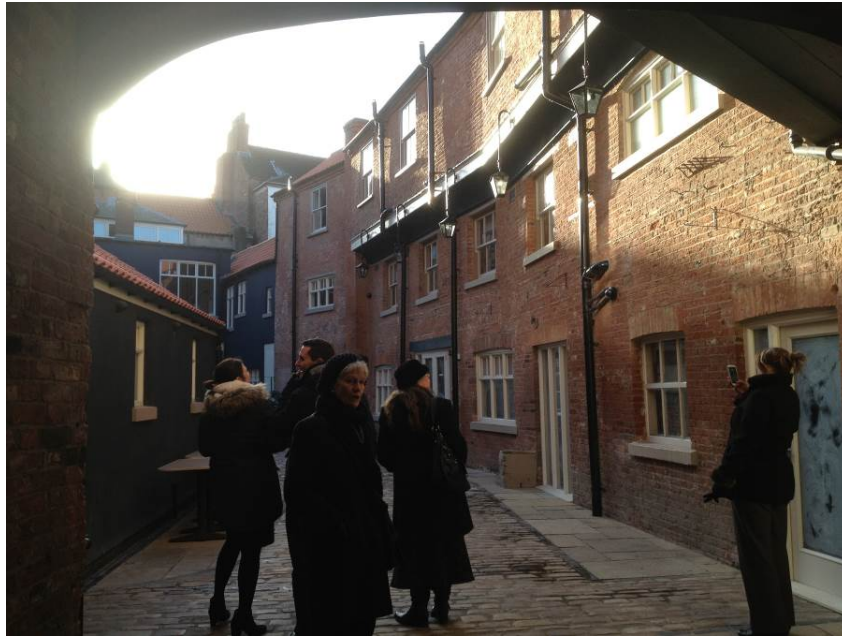
*Fig. 28 Rear courtyard of the restored White Hart © PRT*

Another is the White Hart Hotel which has recently been restored. Fig. 28 shows the courtyard entrance with the windows repaired or replaced and the jettied upper floor retained.

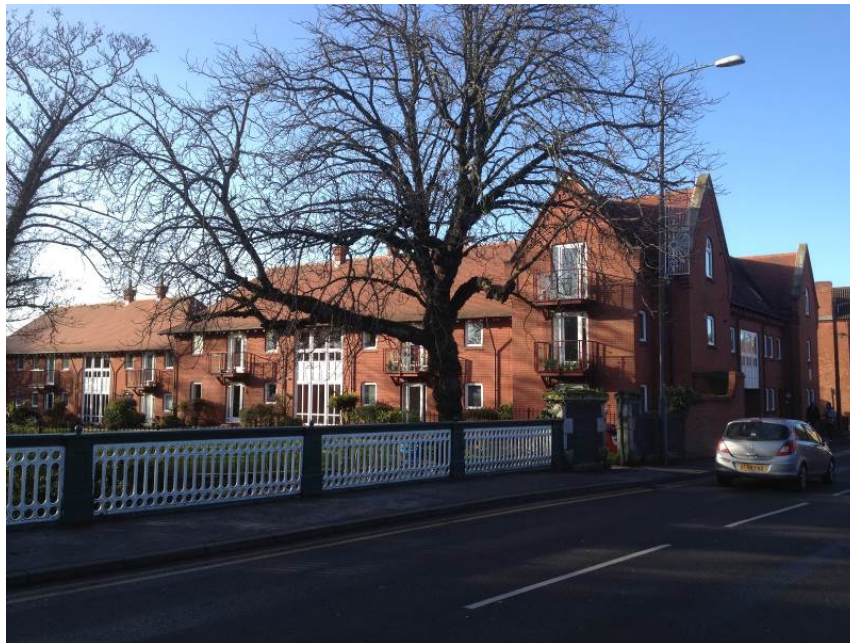
*Fig. 29 Bridgegate development © PRT*

The residential development on Bridgegate just beyond the river shows good attention to scale and materials (Fig. 29).

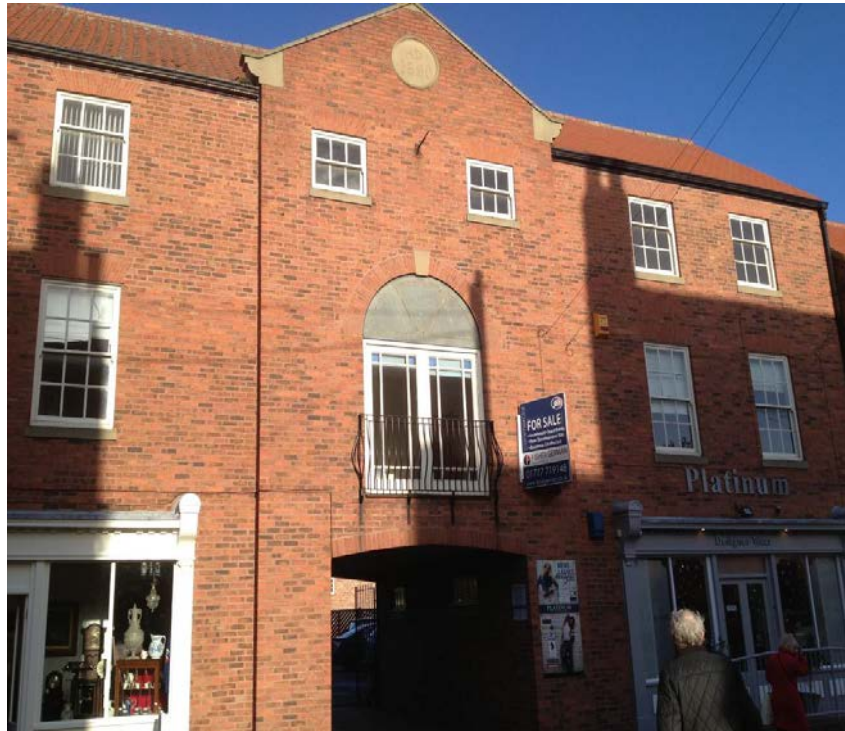
*Fig. 30 Grove Street development © PRT*

By contrast the 1990 residential development on Grove Street is weak in design and detracts from the character of the street (Fig. 30).

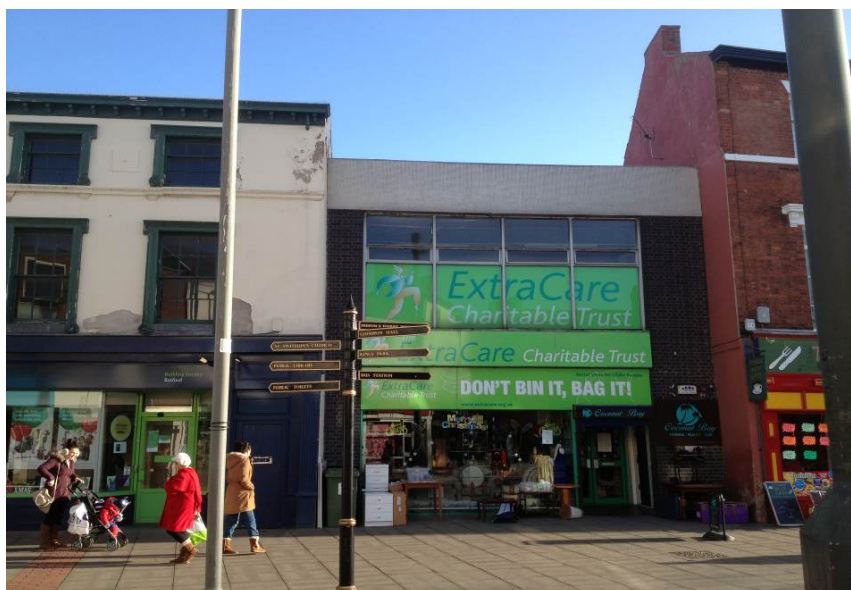
*Fig. 31 Market Square (E side) © PRT*

There are also examples of poor quality infill on more constrained sites in the town. Future infill should seek to blend better with the existing character. Whilst the first example just off the Market Square Street is subservient in scale and is set back, its severely modern style actually makes it more obtrusive (Fig. 31).

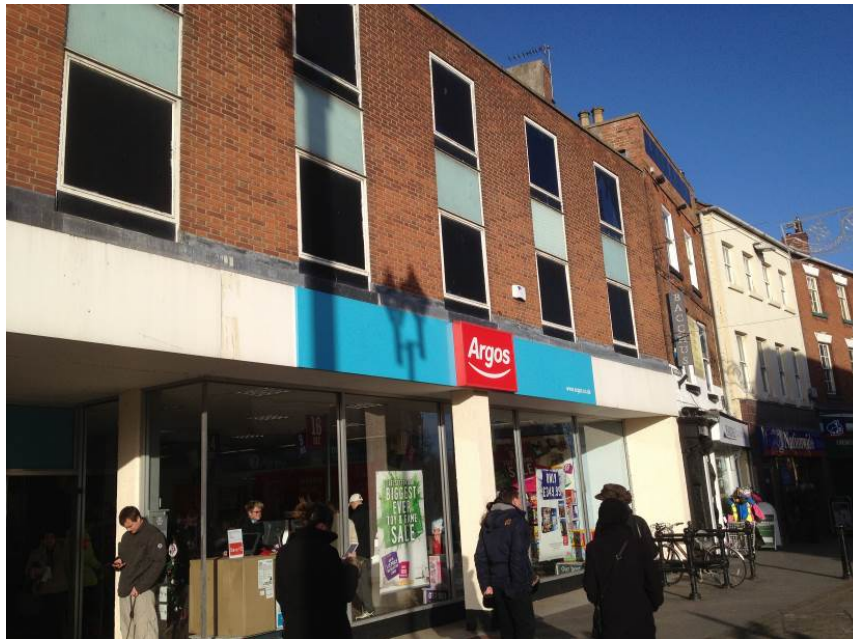
*Fig. 32 Argos in the Market Place © PRT*

Argos has attempted to follow the match the levels of the neighbouring elevations but the style of the fenestration and the scale of the shop front undermines this to leave an unsatisfactory piece of infill development (Fig. 32).

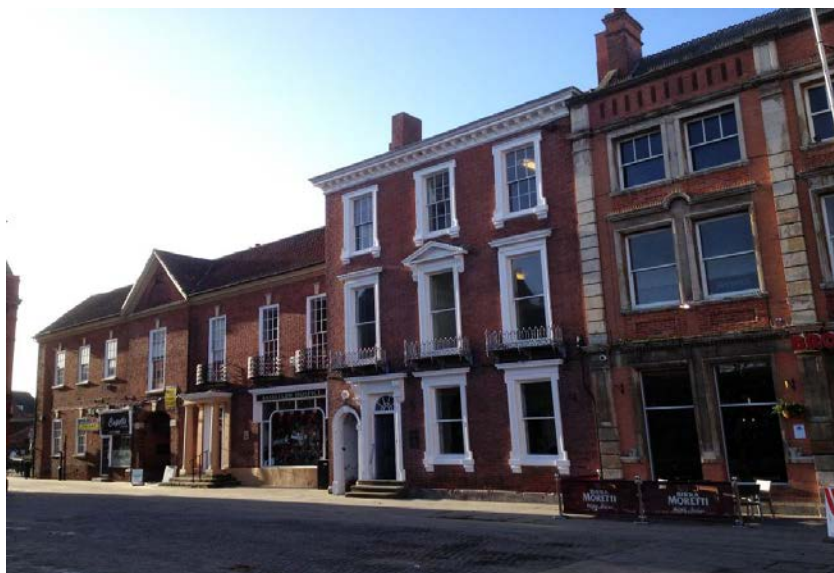
*Fig. 34 Market Square partially occupied buildings © PRT*

5. A number of upper floors in the main square are currently vacant. These have the potential for redevelopment, and may also benefit the area through increased local activity at night. We recommend undertaking investigations into potential partnerships including the Empty Homes Agency to take this issue forward.

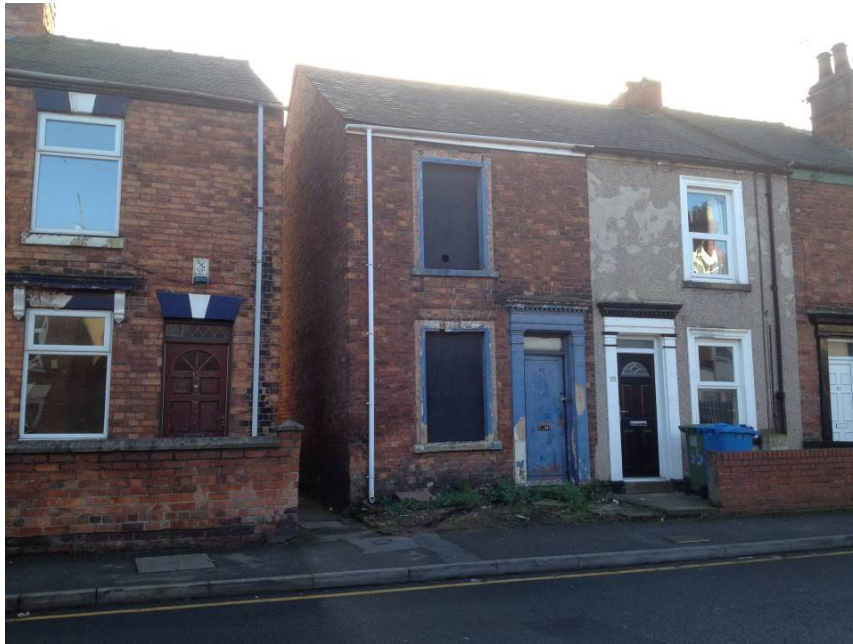
*Fig. 35 empty home on Albert Road © PRT*

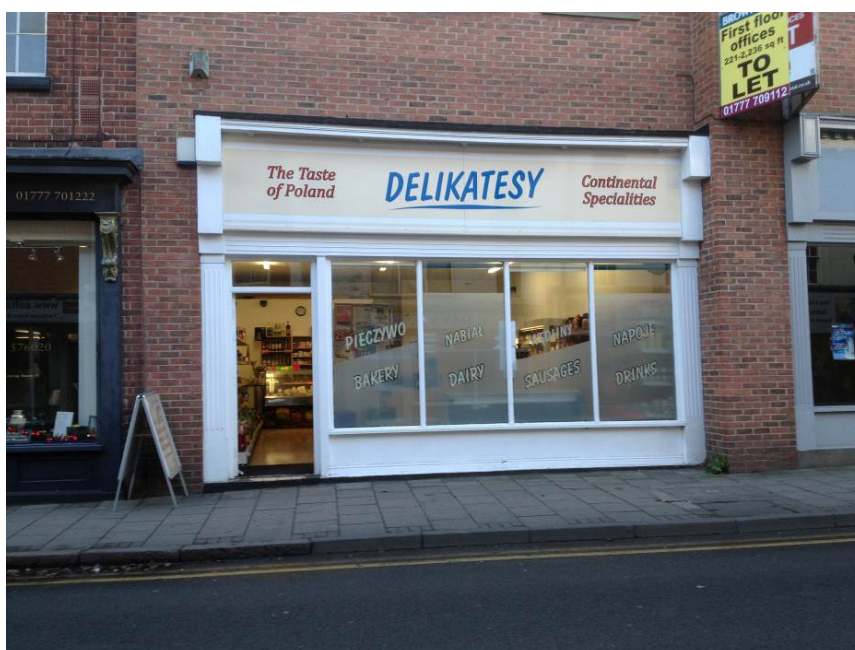
*Fig. 36 Bridgegate © PRT*

Although not overtly illuminated and although on a modern building the depth and flatness of the fascia in Fig. 36 and the heaviness of the end brackets is unnecessarily out of character.

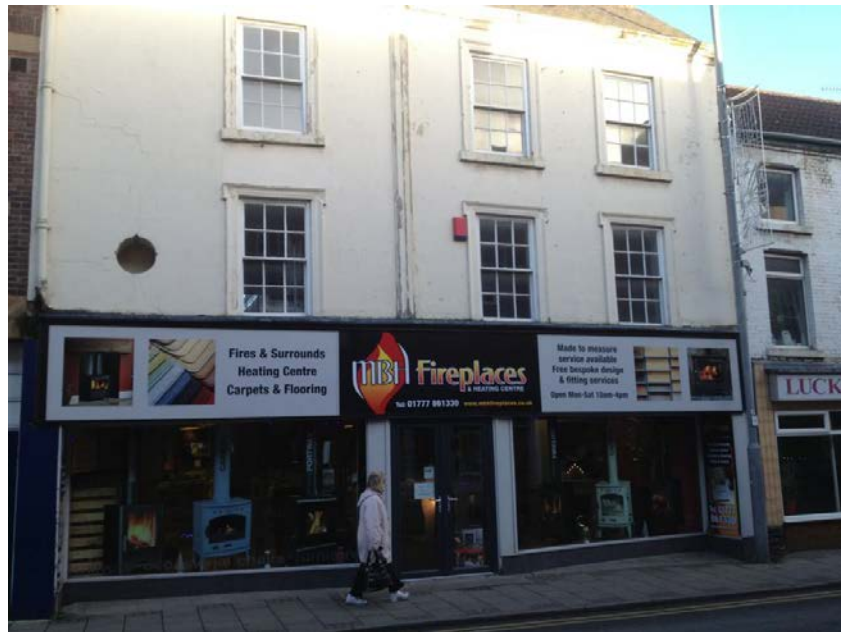
*Fig. 37 Bridgegate © PRT*

This late 18<sup>th</sup>/early 19<sup>th</sup> century Georgian building is severely damaged by the modern shop front which ideally should be wholly replaced. The building appears to have originally been two properties and so a more sensitively designed timber shop front could reflect this for example two doorways into the same retail premises.

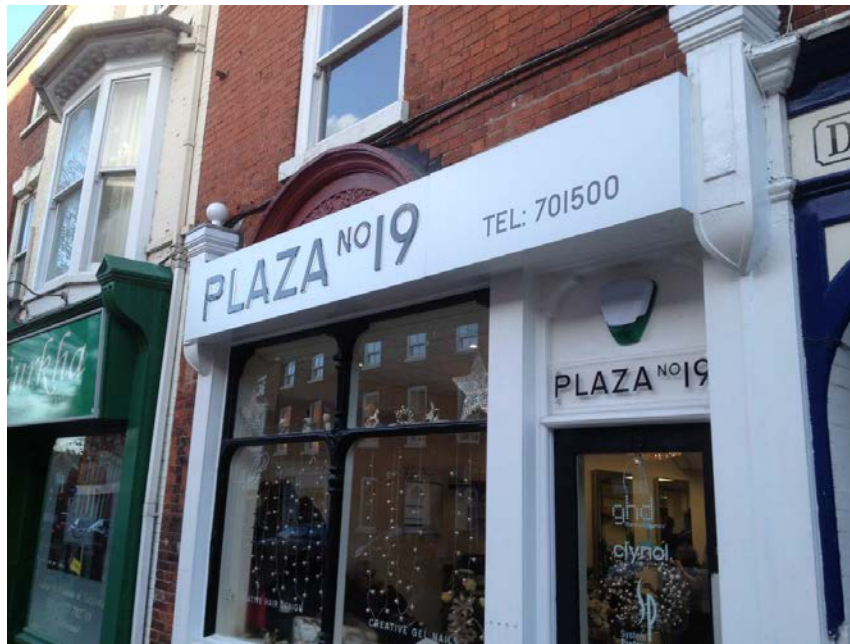
*Fig. 38 Grove Street © PRT*

Here the modern shop front fascia has insensitively cut across the terracotta detailing of the Victorian/Edwardian building and compromised the historic character, which in itself could have been a good way of drawing attention to the shop. The new work has potentially done irreversible damage to the historic detailing underneath.

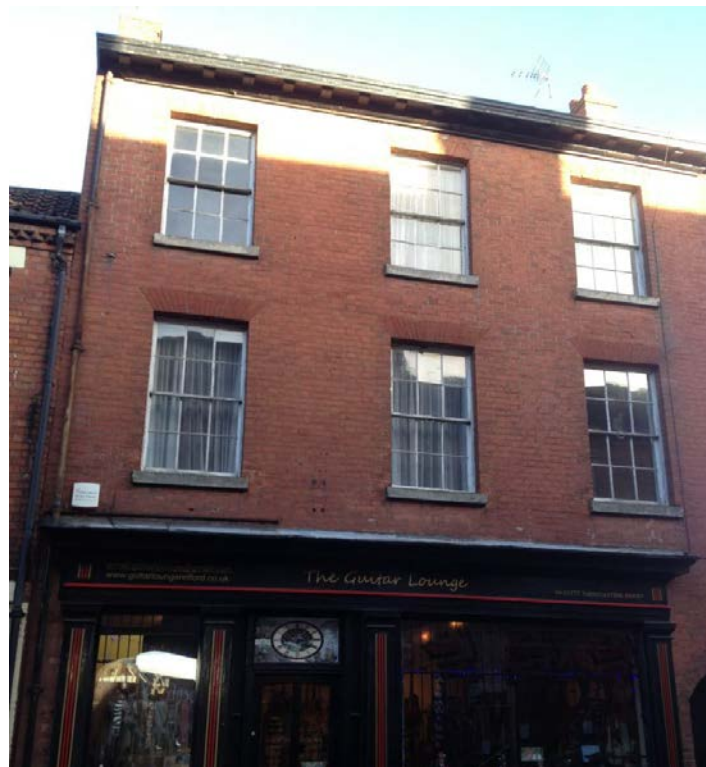
By contrast the following shop on Bridgegate is a good example of a whole building intact, with sympathetic shop front and fenestration above.

*Fig. 39 shop building with well-preserved historic character © PRT*

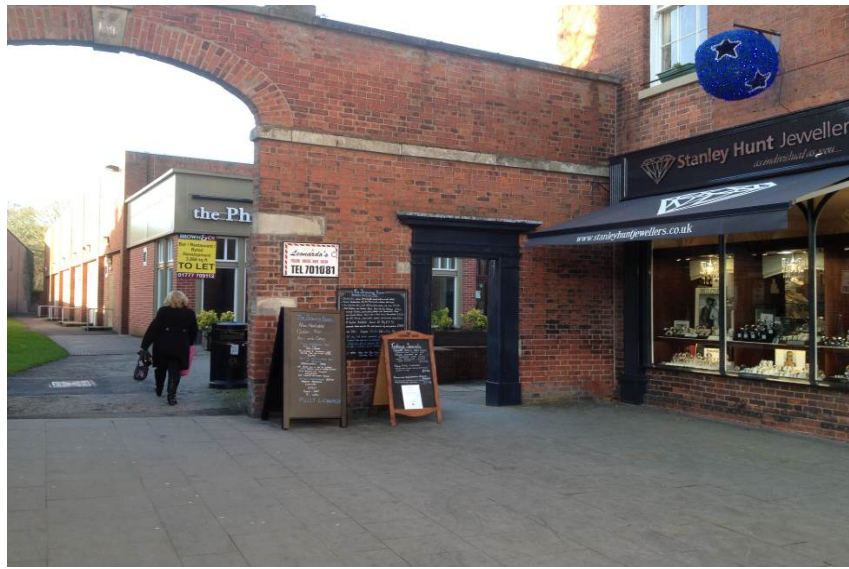
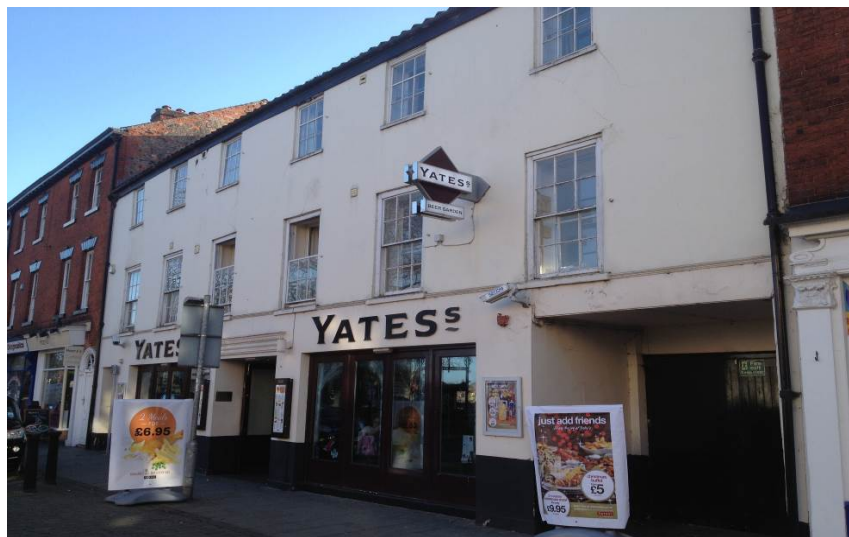
In some areas there is a plethora of A boards, wall signs, banners and other signage (Figs. 40 and 41). These need to be rationalised to avoid the townscape character being undermined. It is especially detrimental to buildings of architectural distinction and too much signage can also be confusing. Ideally signage should be 'as little as possible but as much as is necessary'.

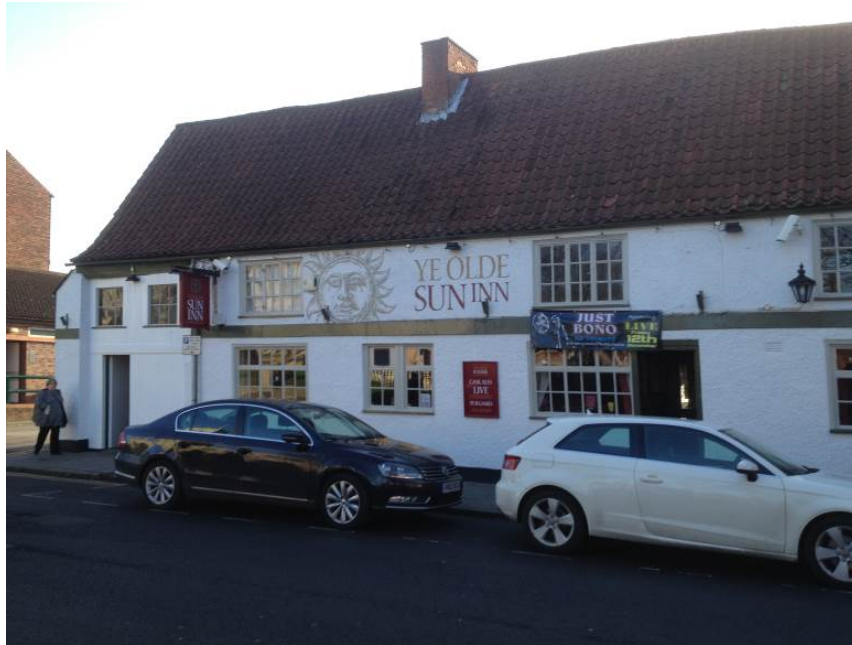
*Fig. 42 Ye Olde Sun Inn, Chapelgate © PRT*

Signage that is hand painted, bespoke and sensitively lit where necessary can add value to the character of the townscape. By the same token signage that is generic, plastic and illuminated by fluorescent panels or prominent swan neck lamps can be highly damaging to the character of the townscape. Ye Olde Sun Inn (Fig. 42) is to be commended for its hand painted pub sign, though the advertising banner in the middle would be best removed and the lighting rationalised.

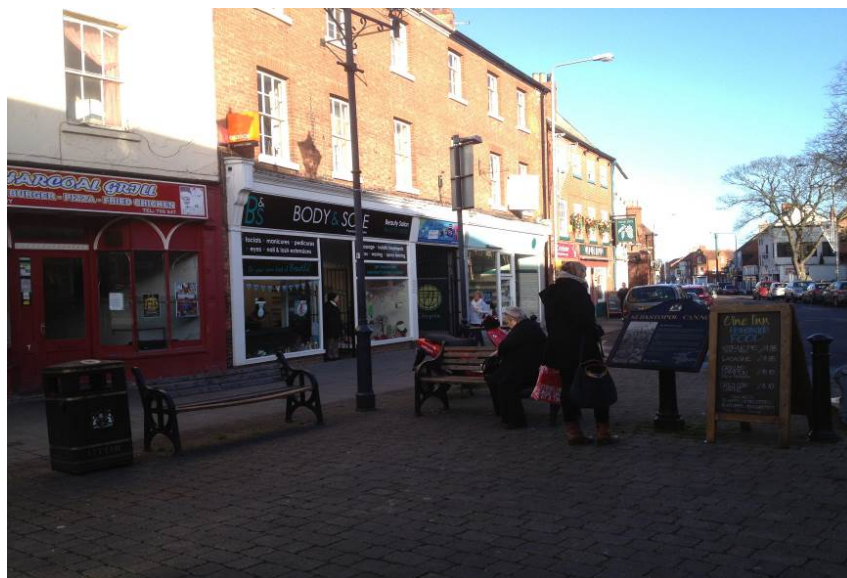
*Fig. 43 Market Place © PRT*

It is important to review the quantity and quality of street furniture. The example on Market Place (Fig. 43) creates a feeling of obstruction rather than enhancing movement through and along the street. The challenge is to provide facilities such as litter bins and benches and notice boards in ways that are clearly located but not visually intrusive. A palette of materials and colours helps to achieve this. Following from that it would be good when litter bins need replacing to agree a common style for example those introduced as part of the public realm works around the Market Square.
