## **Retford**

**Regeneration Workshop  
10 December 2014**

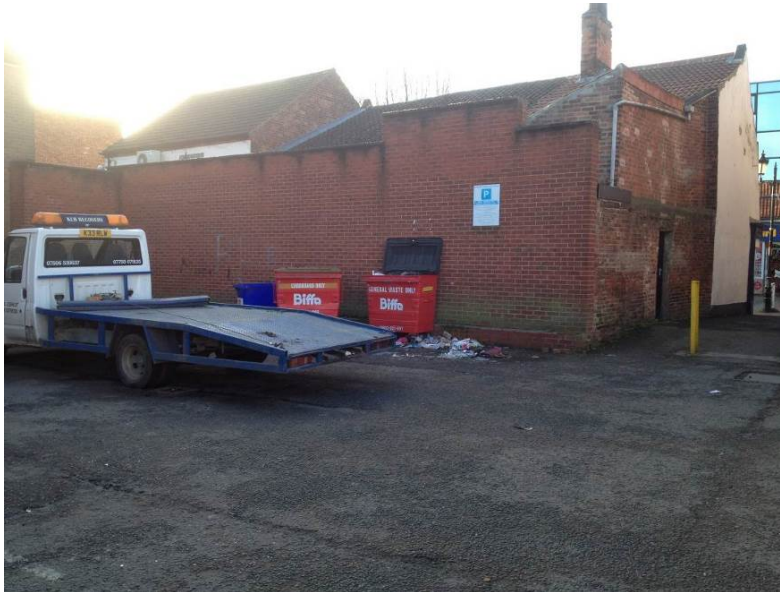
*Fig. 44 litter behind Carolgate © PRT*

To the rear of Carolgate (Fig. 44) there is a particular problem with unguarded refuse bins the contents of which are being strewn across the pedestrian thoroughfare to the main shopping street. Better management of waste disposal by neighbouring shops or night time closure of this area is needed to control adverse effects on the appearance of the townscape.

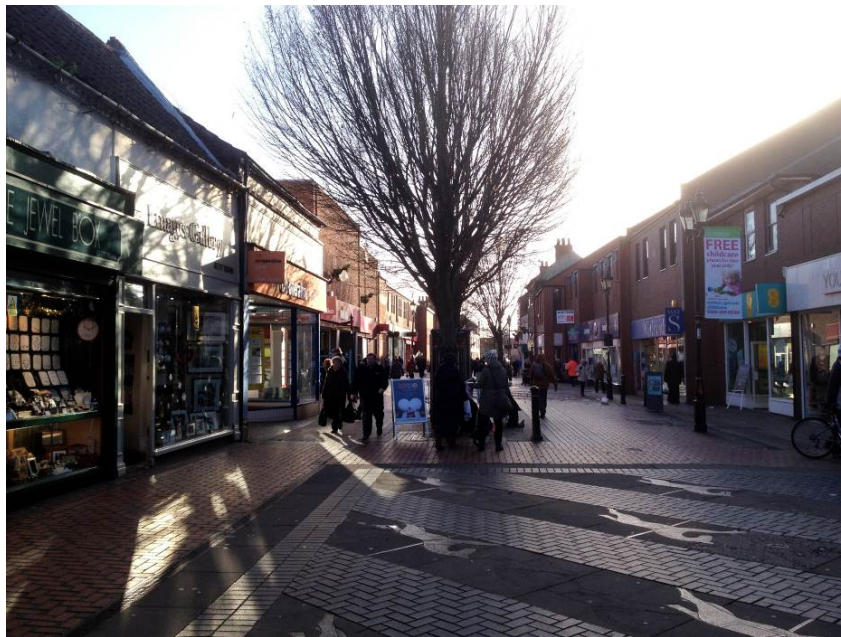
*Fig. 45 Carolgate © PRT*

Decorative paving can add vibrancy to largely modern pedestrianized areas such as Carolgate (Fig. 45) but it can also create, as is the case here, a rather harsh appearance. The surfaces have been degraded by repairs that have not matched the materials. Any new areas of decorative paving in any parts of the town should be in a palette that is easy to maintain and there should be clear instructions to road engineers and service providers that any intervention (e.g. underground cabling) must carefully carry out like for like repairs on completion.

2. Any new areas of decorative paving in any parts of the town should be in a palette that is easy to maintain and there should be clear instructions to road engineers and service providers that any intervention (e.g. underground cabling) must carefully carry out like for like repairs on completion.
3. It is essential that the long view through to the church is maintained.
4. The town centre is characterised by a number of connecting alleys and passageways and it is essential that these are retained and enhanced.
5. The decorative murals should be retained as they are unique features for the Town. Similarly, original signage such as above the old launderette should be preserved as it provides an interesting insight to the town centre's history.
6. To safeguard the interior, the Museum should remain as is, and ideally should be protected from spending cuts.

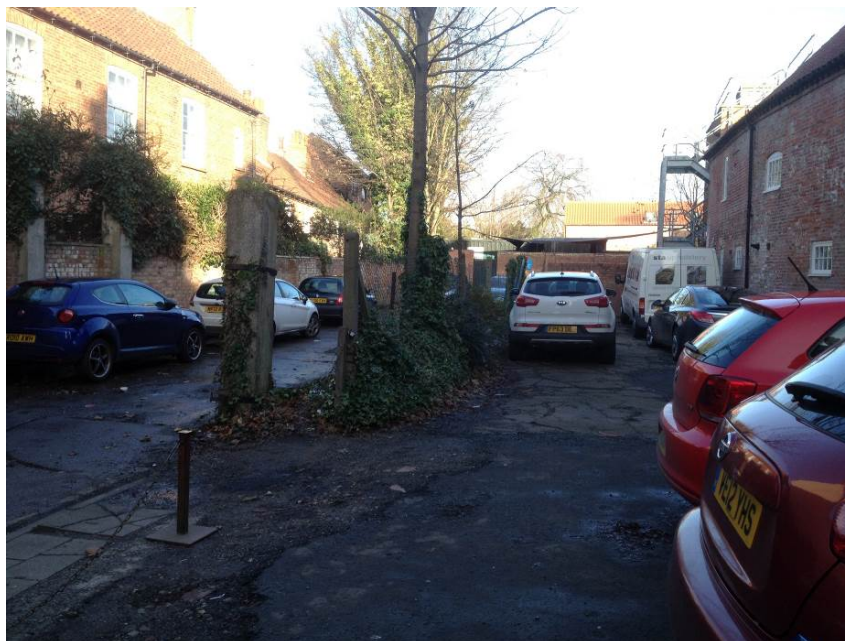
*Fig. 46 Bridgegate © PRT*

In several areas of the town there is a problem of seemingly random car parking and in some cases this mars the appreciation of key buildings and spaces and it creates an untidy character.

The walking tour identified opportunities to rationalise car parking around the bus station area and near Bridgegate (Fig. 46) where there could also be the opportunity for parking to be incorporated into a high quality new development.

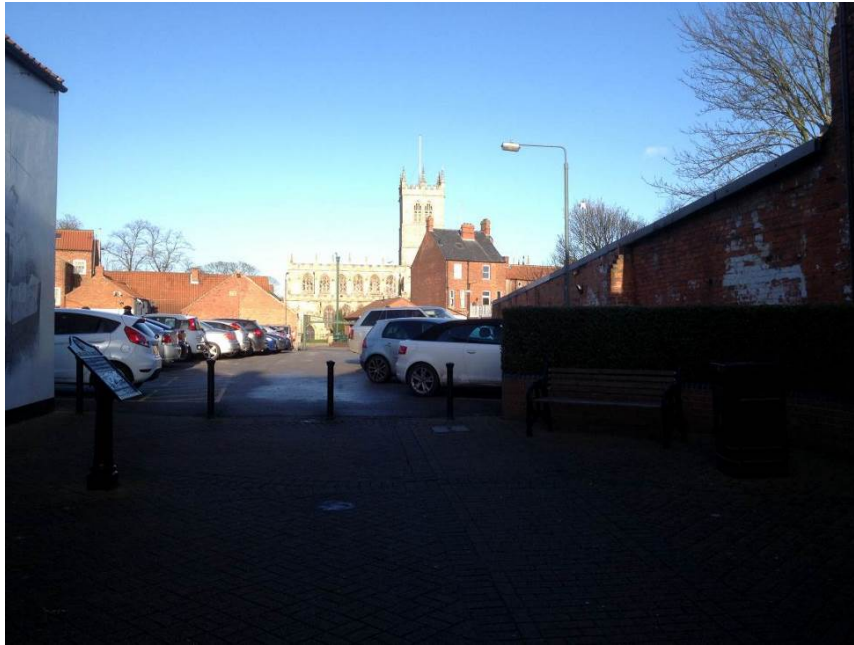
*Fig. 47 end of Dyers Court © PRT*

Fortunately the vista through from Dyers Court (Fig. 47) towards the church is retained and it is important that any amendments to the layout of this parking area in the future should maintain this.

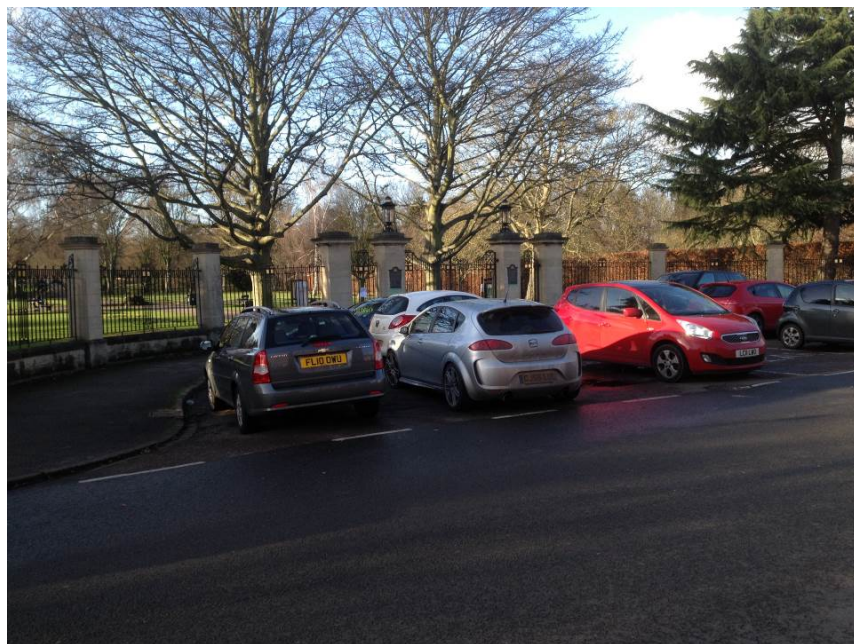
*Fig. 48 Parking in front of entrance to King's Park © PRT*

The car parking at King's Park, however, is obscuring the sense of arrival (Fig. 48). The gated entrance screen is a fine piece of townscape and the entrance to the park needs to be viewed and approached without interruption by vehicles. King's Park was opened in June 1938 to commemorate the reign of George V and the coronation of George VI.
