## Guidance Note: Pantile Roofs Repair and Replacement

January 2011

**Bassetlaw**  
DISTRICT COUNCIL  
— North Nottinghamshire —

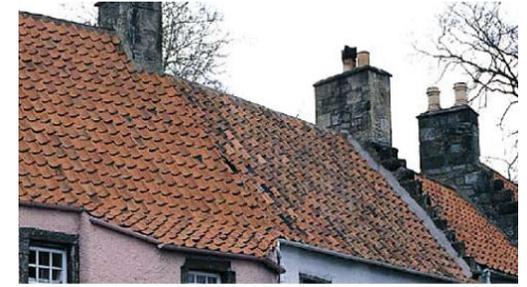
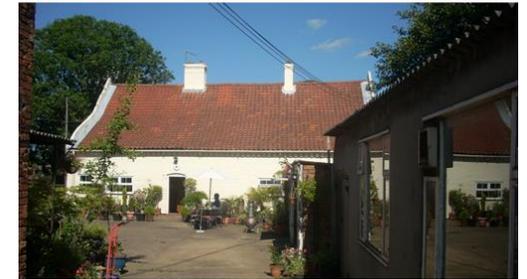
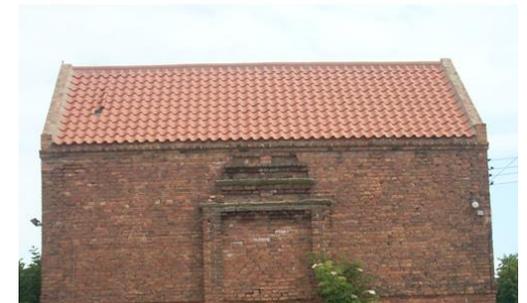
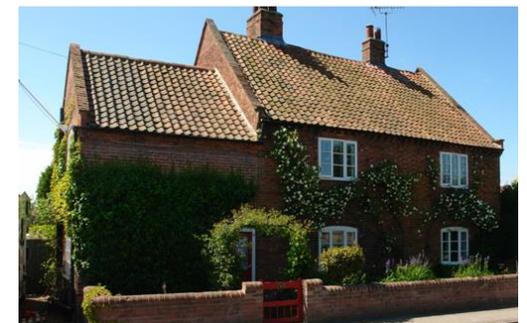
A pantile roof has a series of regularly spaced horizontal battens attached to the rafters (on which the tiles are hung). The tiles have a projecting nib on the back. This small projection on the rear of the tile holds it in position when laid on the batten. The battens should be placed evenly to ensure the tiles maintain the appropriate lap over their underlying neighbour. Pantiles are laid so that the downturn of one overlaps the upturn of the next on the same course. This forms a system of ridges and troughs, which concentrates rainwater into the centre of the pan. Rainfall on the flanks of each tile is also deflected away from the side rolls and into the centre. Over a series of courses, this system channels the water down the roof slope. The ridge of a pantile roof is normally also protected by clay ridge tiles. These can either be half-round or 'V' shaped. This provides extra security to the fixing and added protection from the weather by preventing wind uplift.

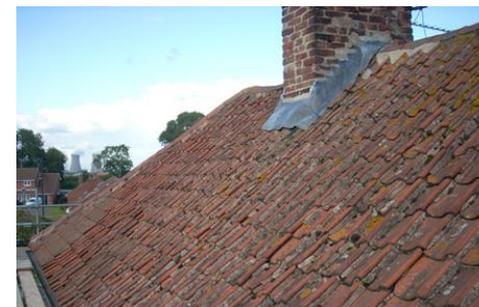
**Half round  
Ridge**

The ridge of a pantile roof is normally protected by clay ridge tiles. These can either be half-round or a loose 'V' shape, known as a 'hogsback'. York stone ridge tiles are also seen in the District but are less common.

The above pictures are examples of the permitted ridge tiles. Courtesy of William Blyth
