BASSETL. DISTRICT COUNC December 2012

Title:	Listed Buildings at Risk in Bassetlaw 2012.
Summary:	This document provide service users with information about how redundant, vulnerable or decay historic buildings and a register of which buildings are currently regarded as being at risk by the Council.
Approved:	This document was approved by Planning Committee on 6 <sup>th</sup> February 2013 at Retford Town Hall. The document was published on 7 <sup>th</sup> February 2013.

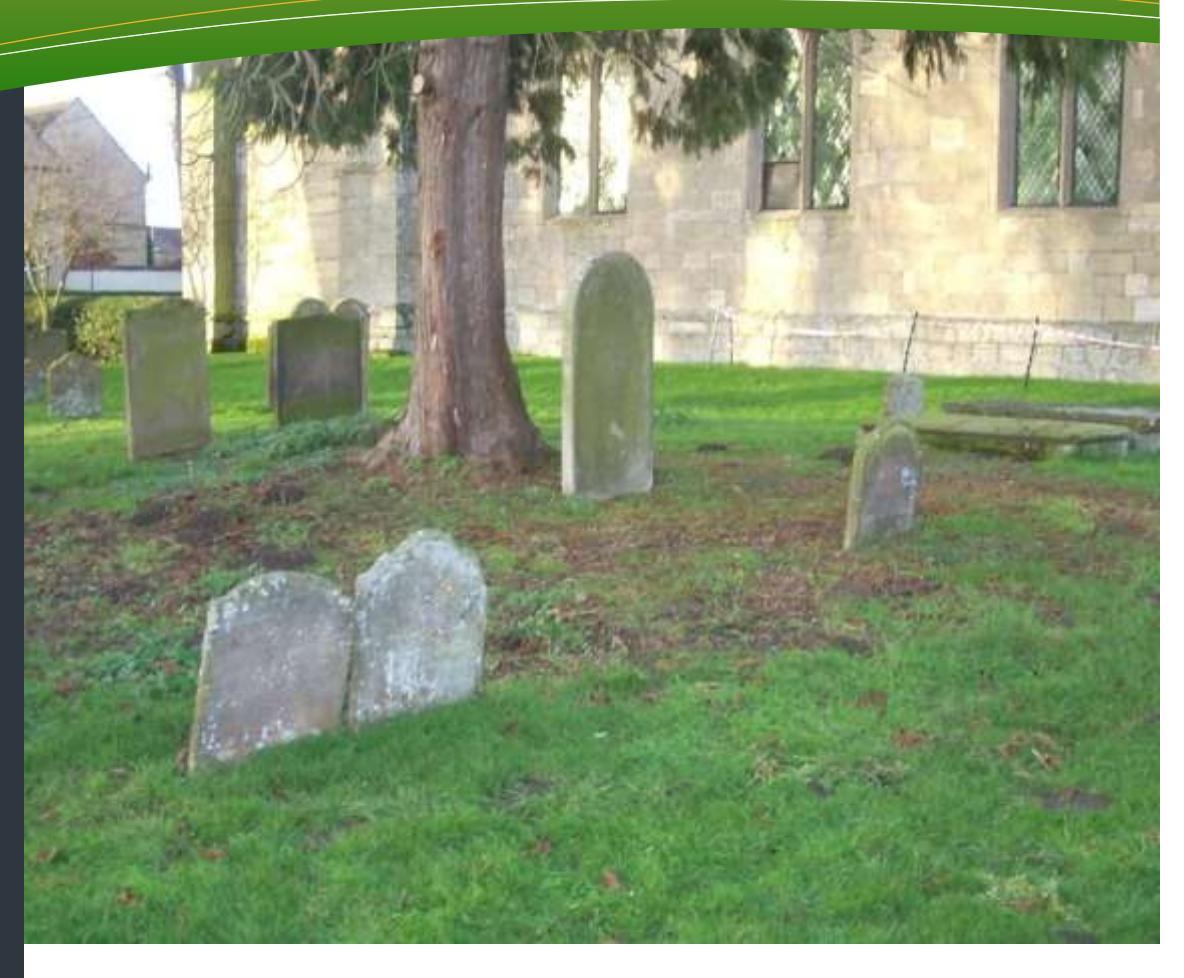
**Risk level:** 3A – at risk

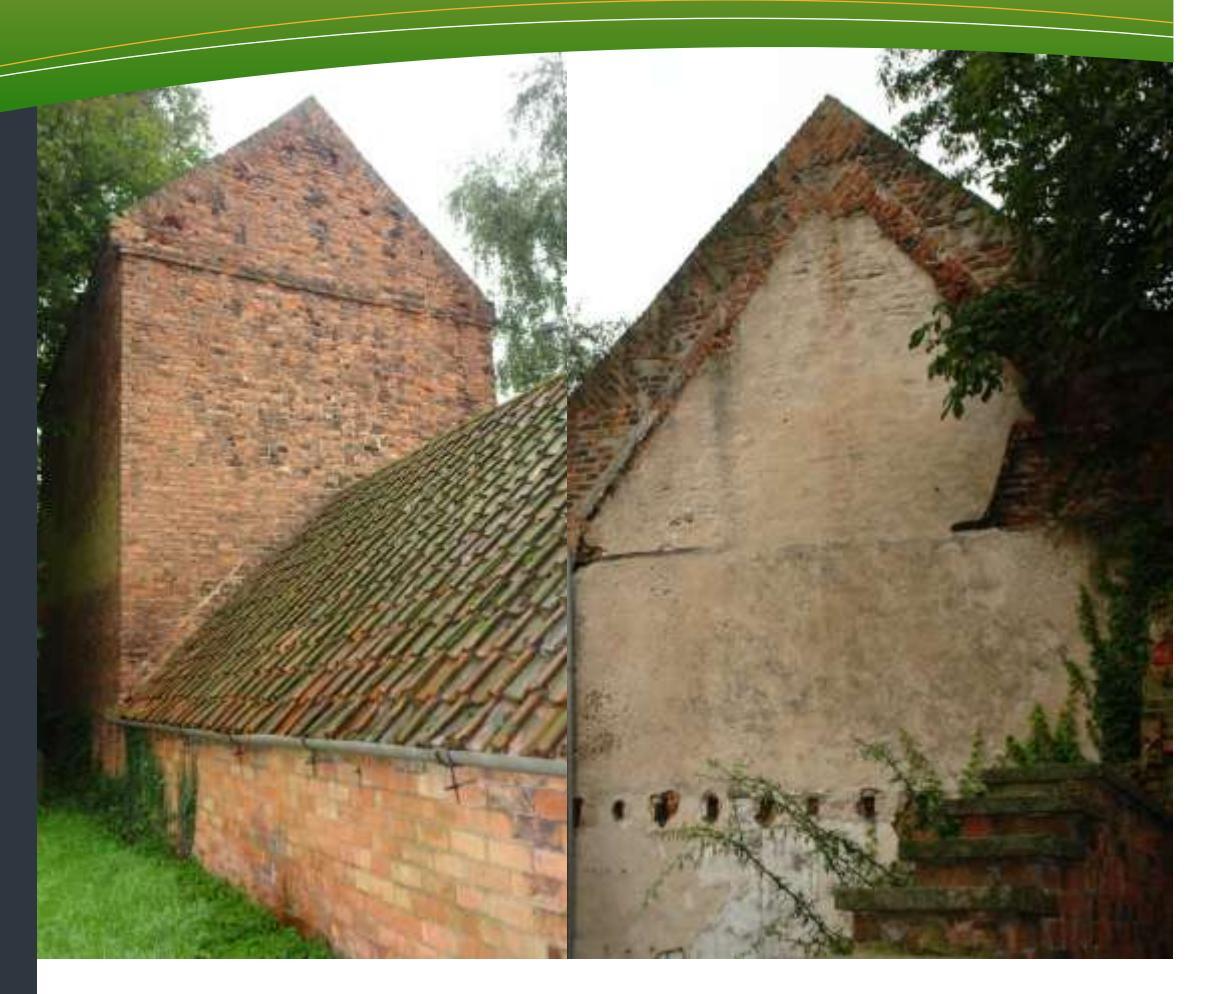
Risk level: 3 – at risk

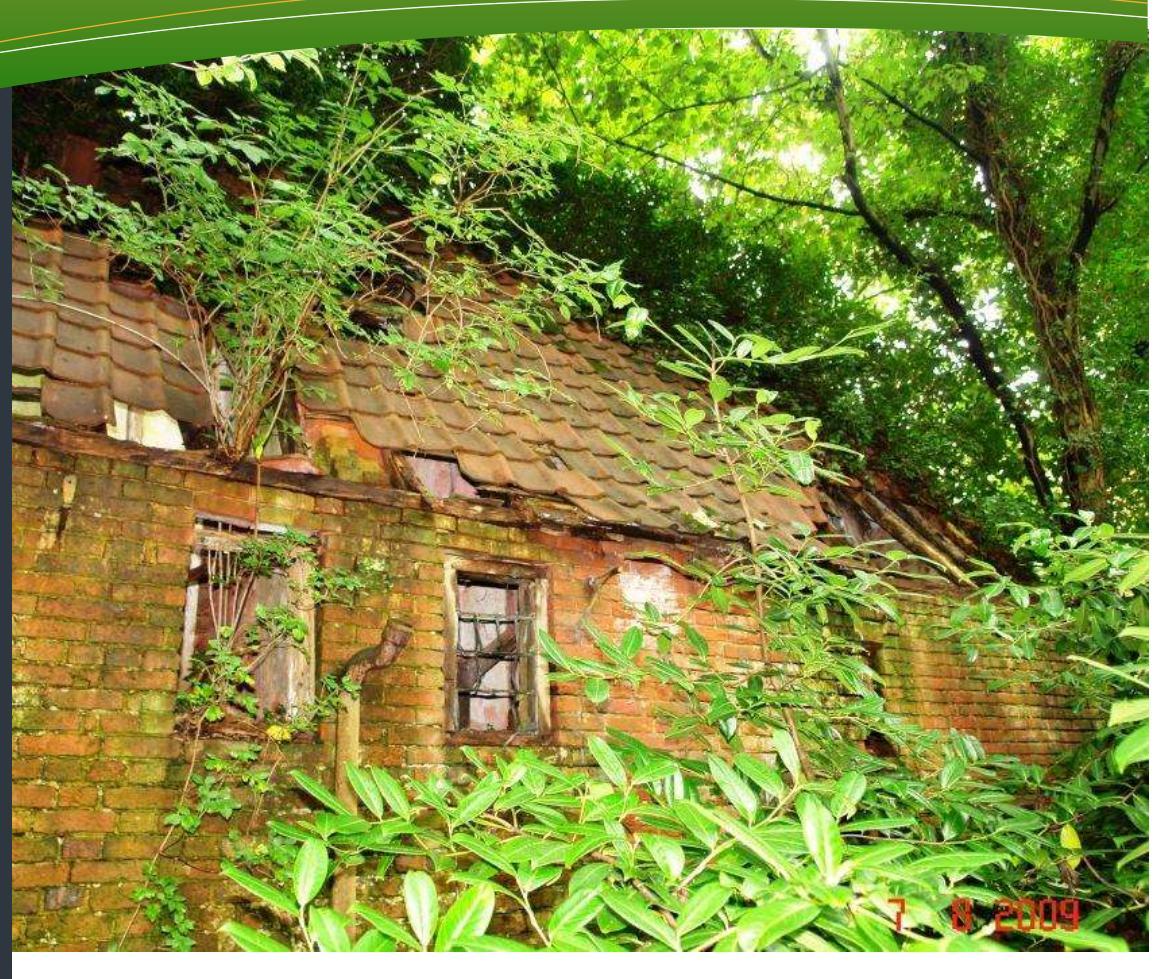
Risk level: 1 – extreme risk

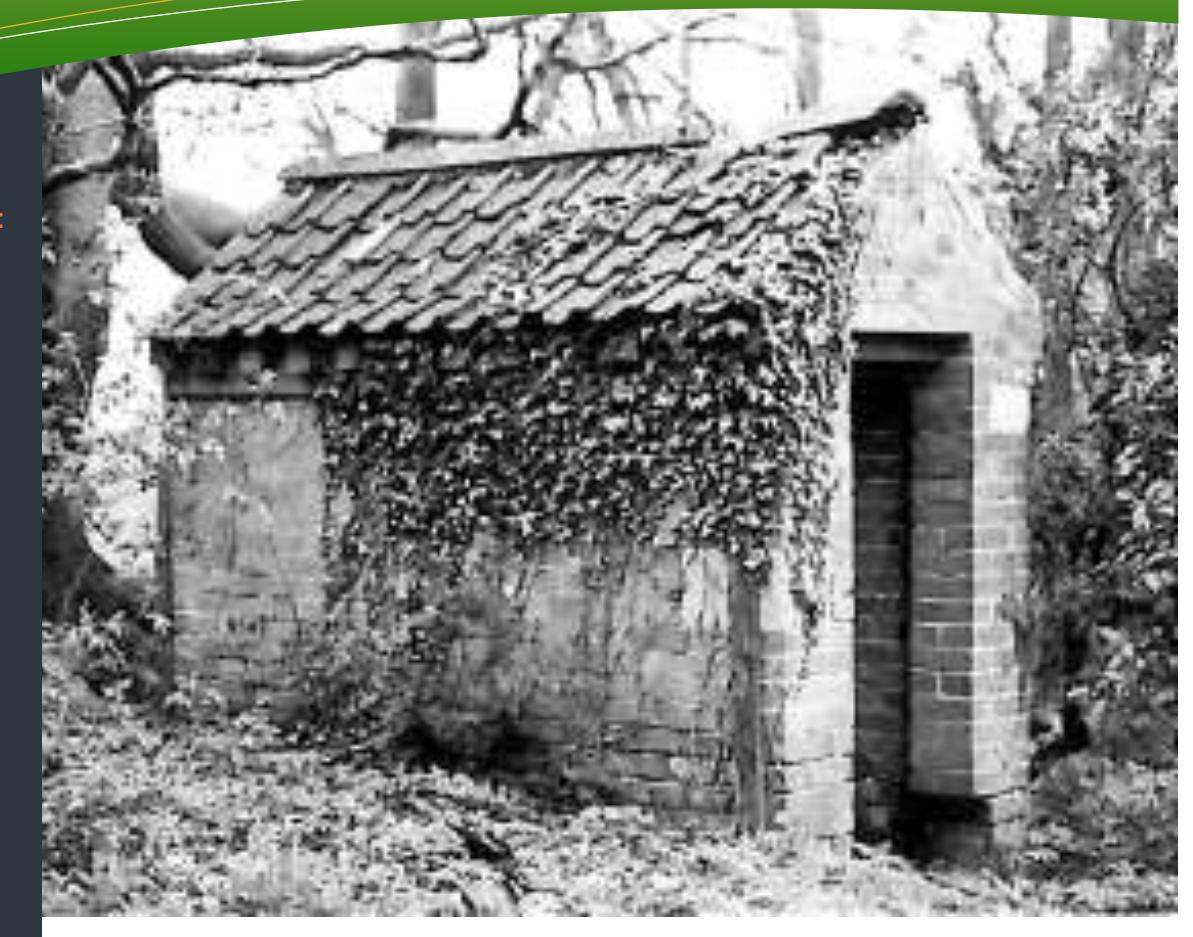
The roof is in need of repair. Vegetation is a problem.

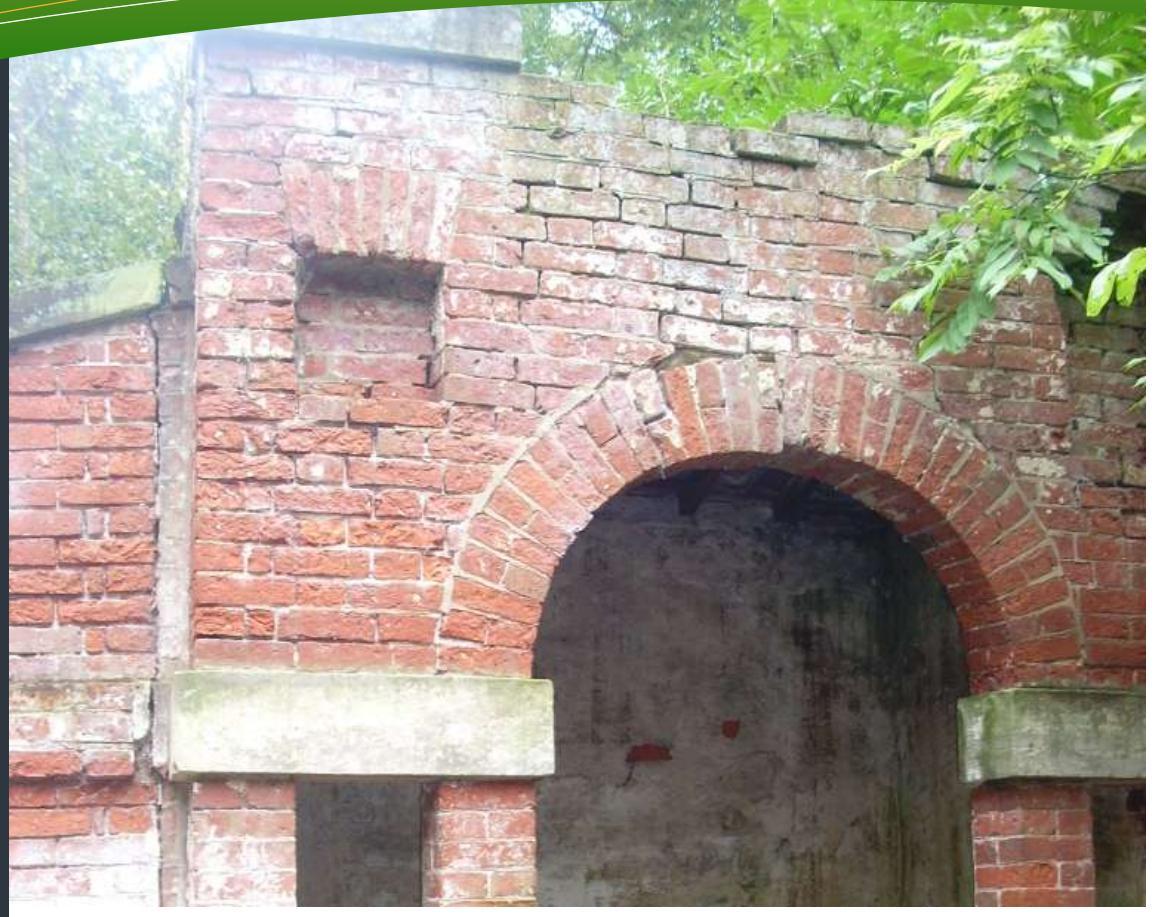
Garden seat in

Collapsed north pier. Cracks in south pier; evidence of subsidence.

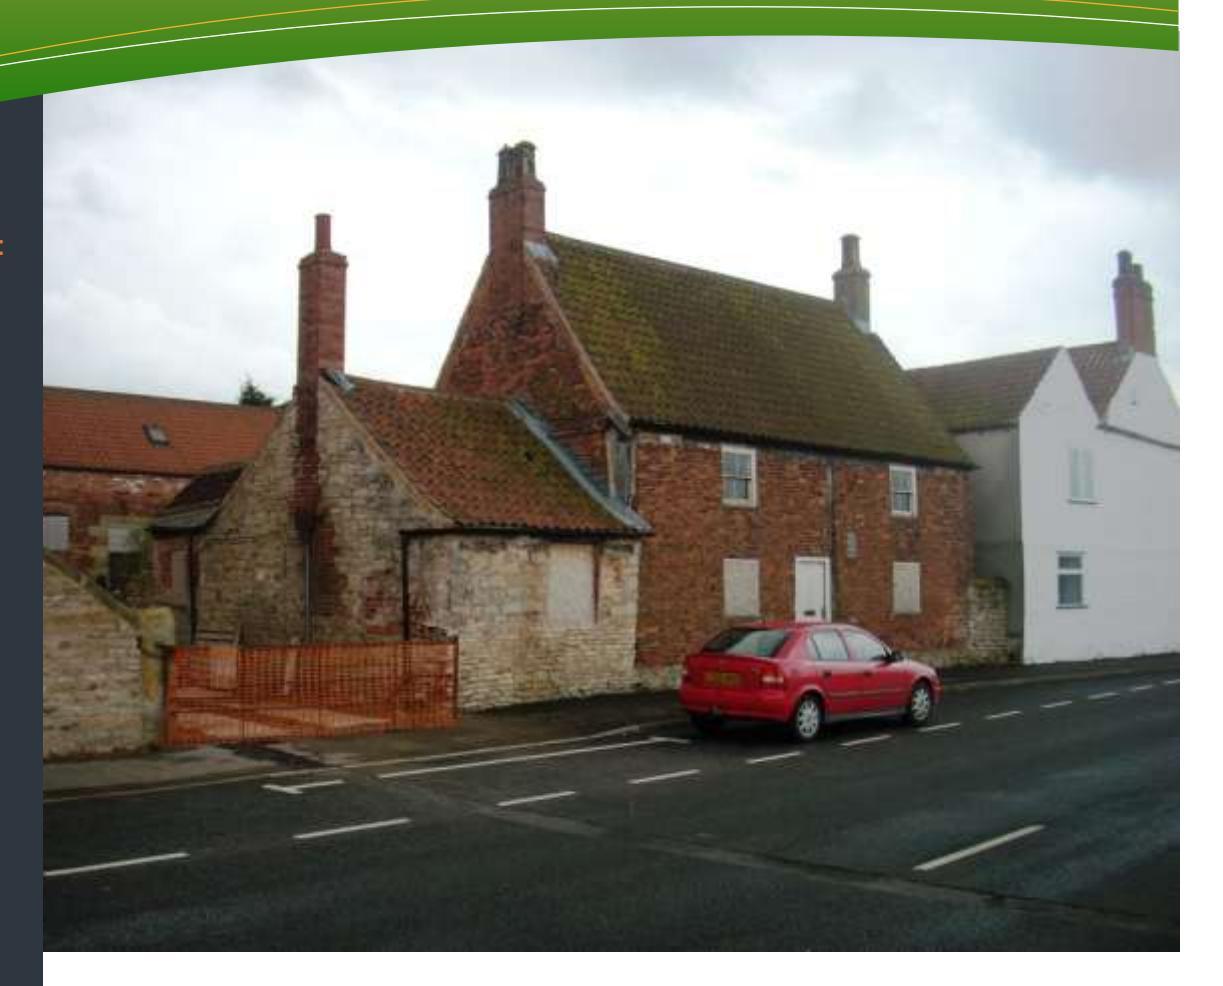
Building is vacant. It is, however, watertight and in good condition. The ground floor windows are boarded up, the roof has been repaired.

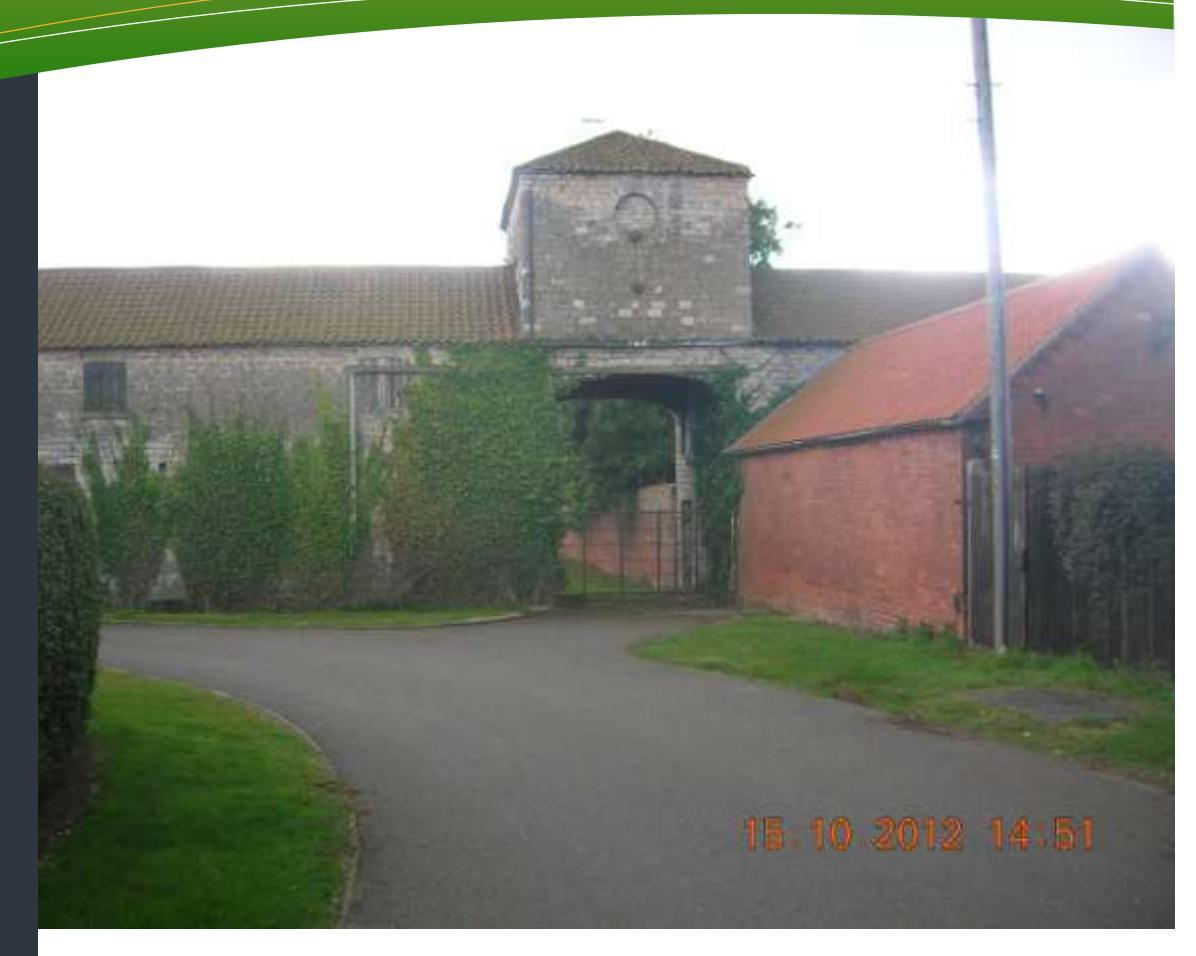
# Stable block, barn and attached outbuildings at the Mantles

Section of roof is deteriorating and there is vegetation growth on walls.

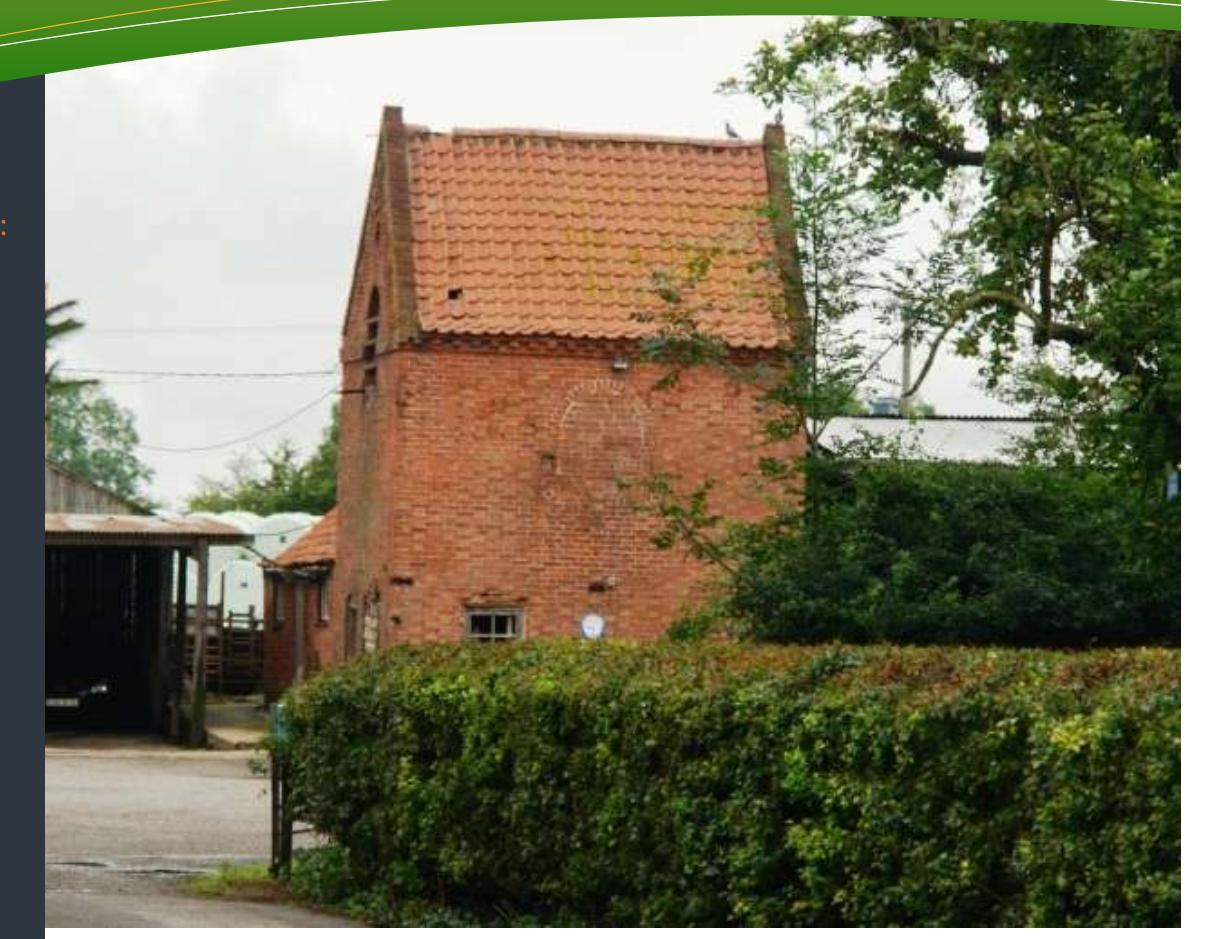
Roof and masonry are deteriorating with a small hole in the roof and a lost ridge tile. Masonry over the small side window showing signs of fracture. Otherwise shows signs of general neglect.

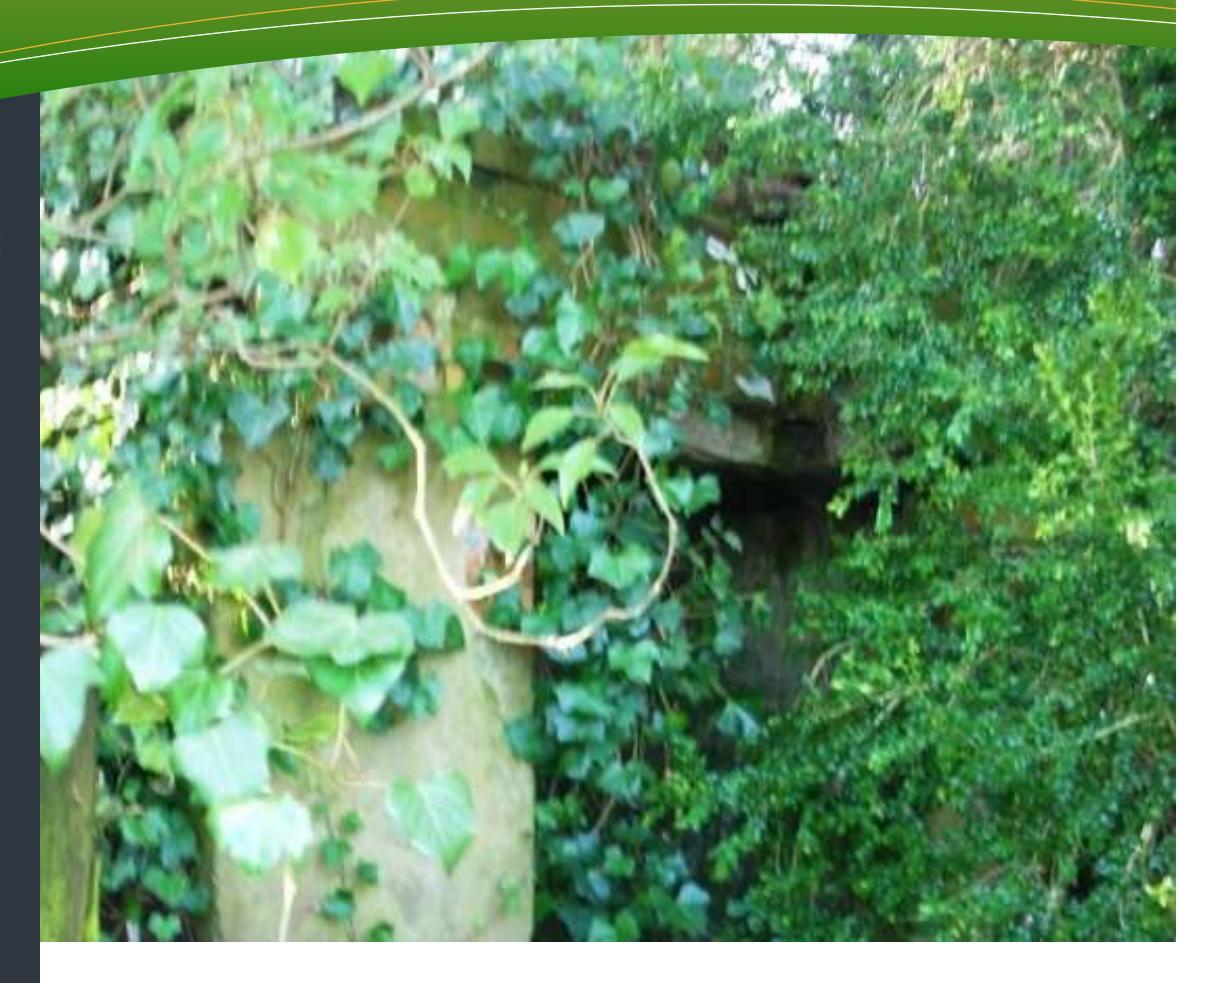
Unused and in very poor condition. Trees are growing out of the roof and causing damage to the structure. Partial masonry collapse.

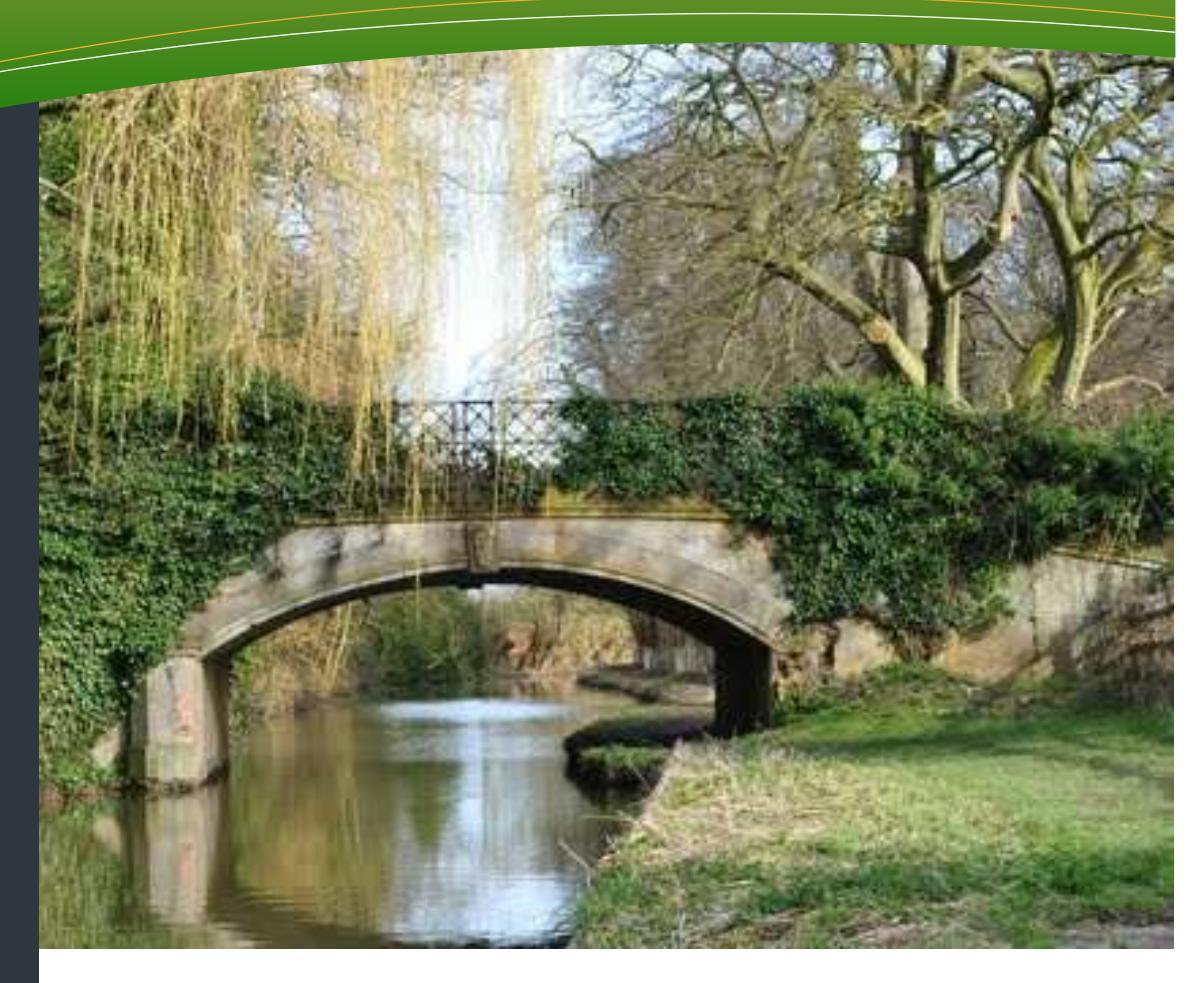
Lady's Bridge

Corroding railings, excessive ivy growth and loss of render. One pier has collapsed.

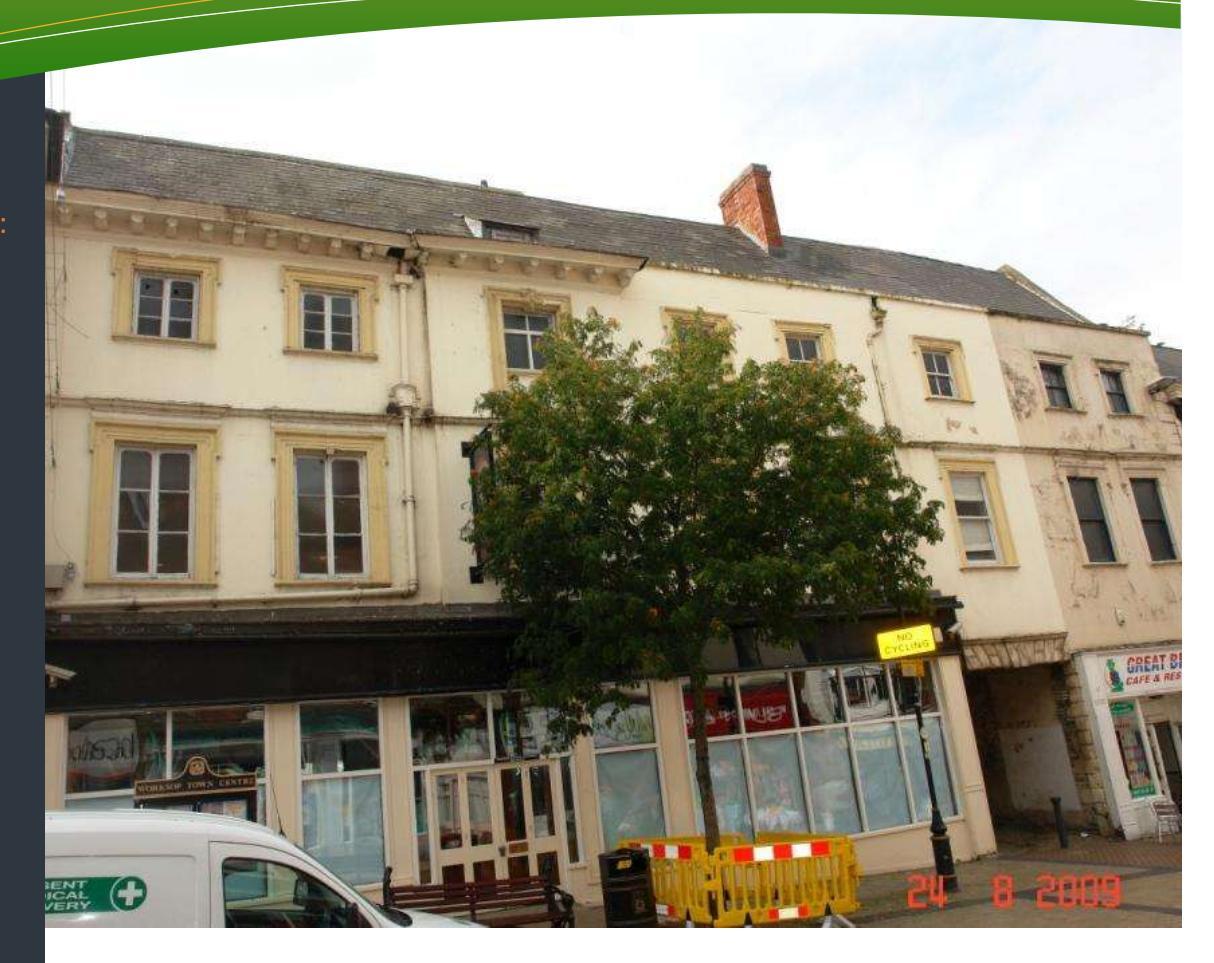
This building is partially occupied at ground floor only. There is no internal access other than by ladder to 106. Externally the gutters are blocked. Window repairs needed to front and rear elevations. The eaves to front are damaged. Pigeon roosting is a problem. Render is failing.

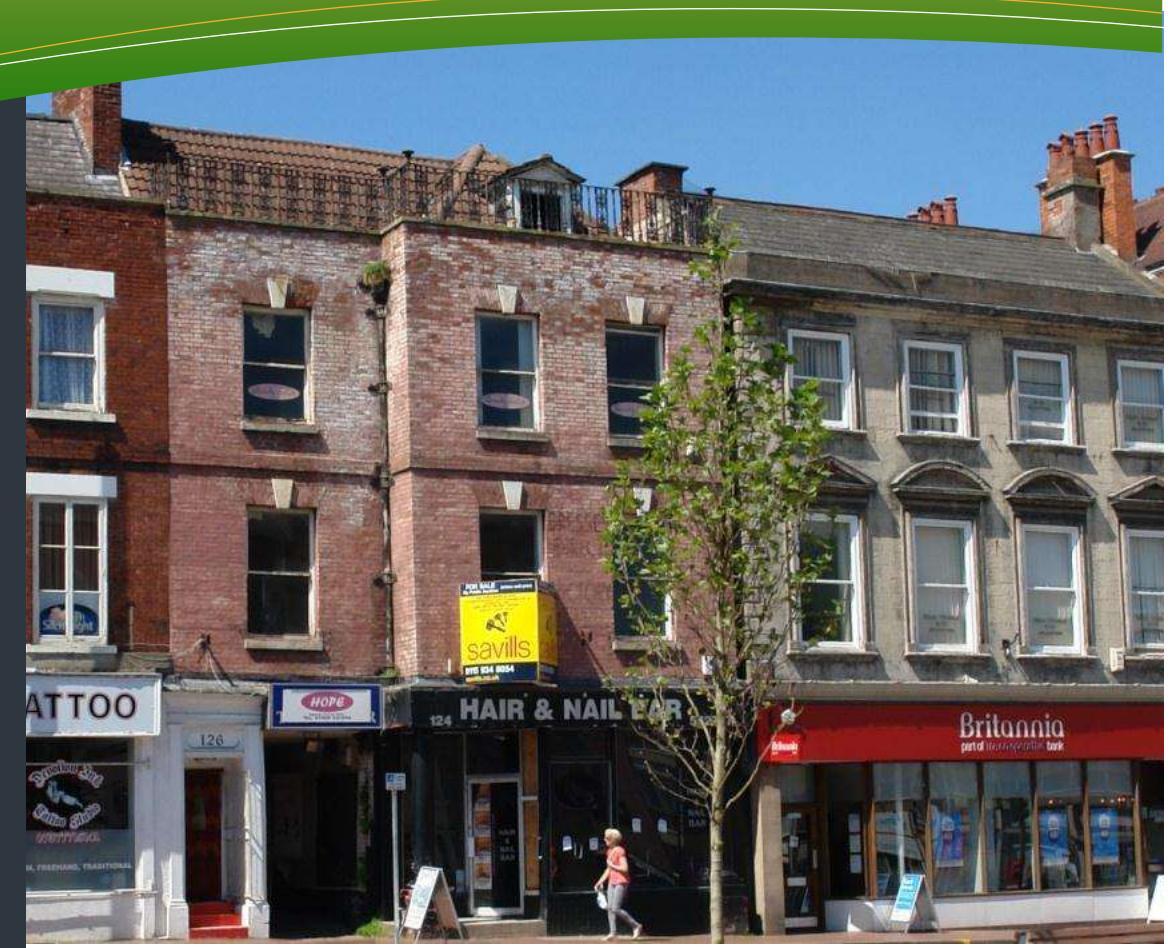
Lead stolen from front roof parapet and dormer damaged, resulting in water ingress and damage to internal plaster. Currently vacant.

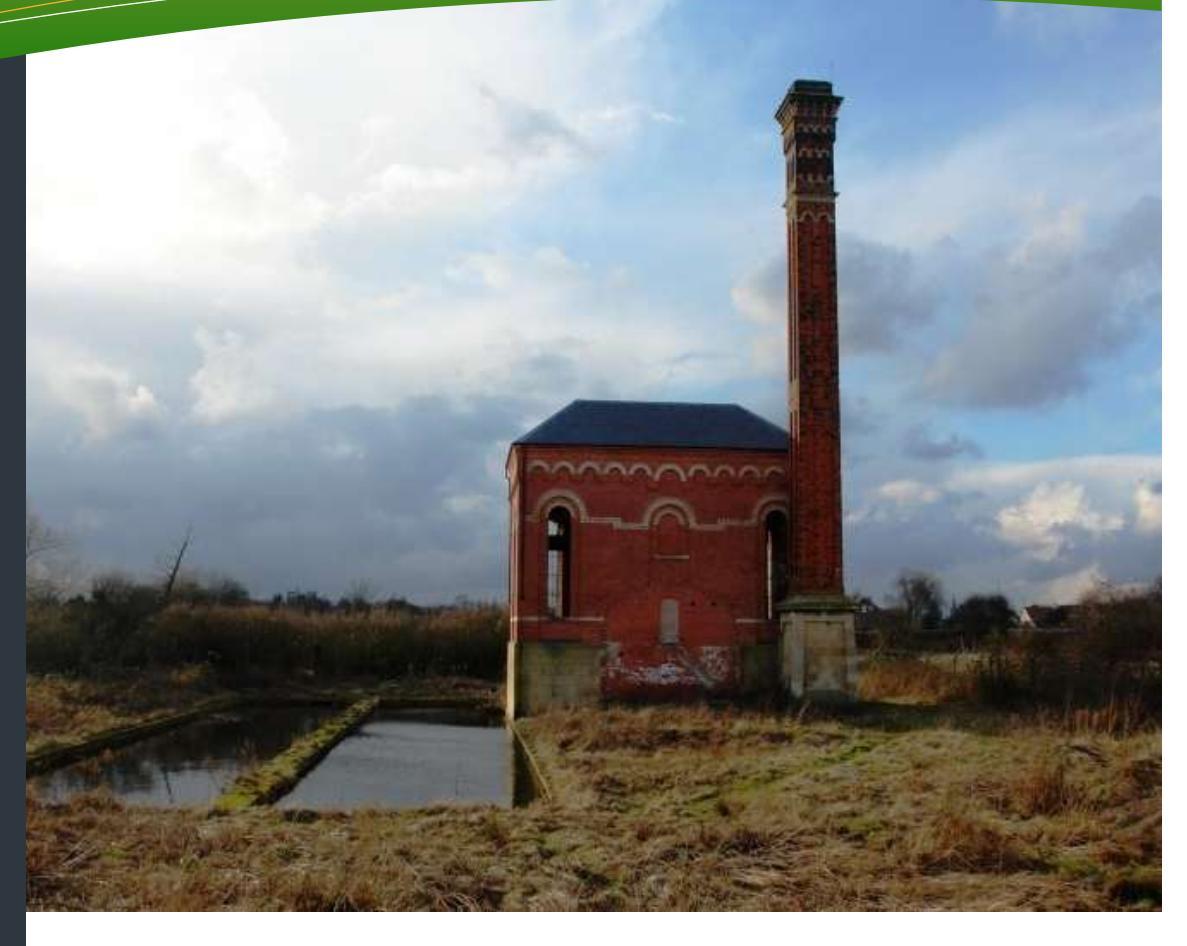
Vacant. Fairly recent maintenance work has left the roof and much of the masonry in good condition. The windows are unglazed, which could cause deterioration. In a stable condition.

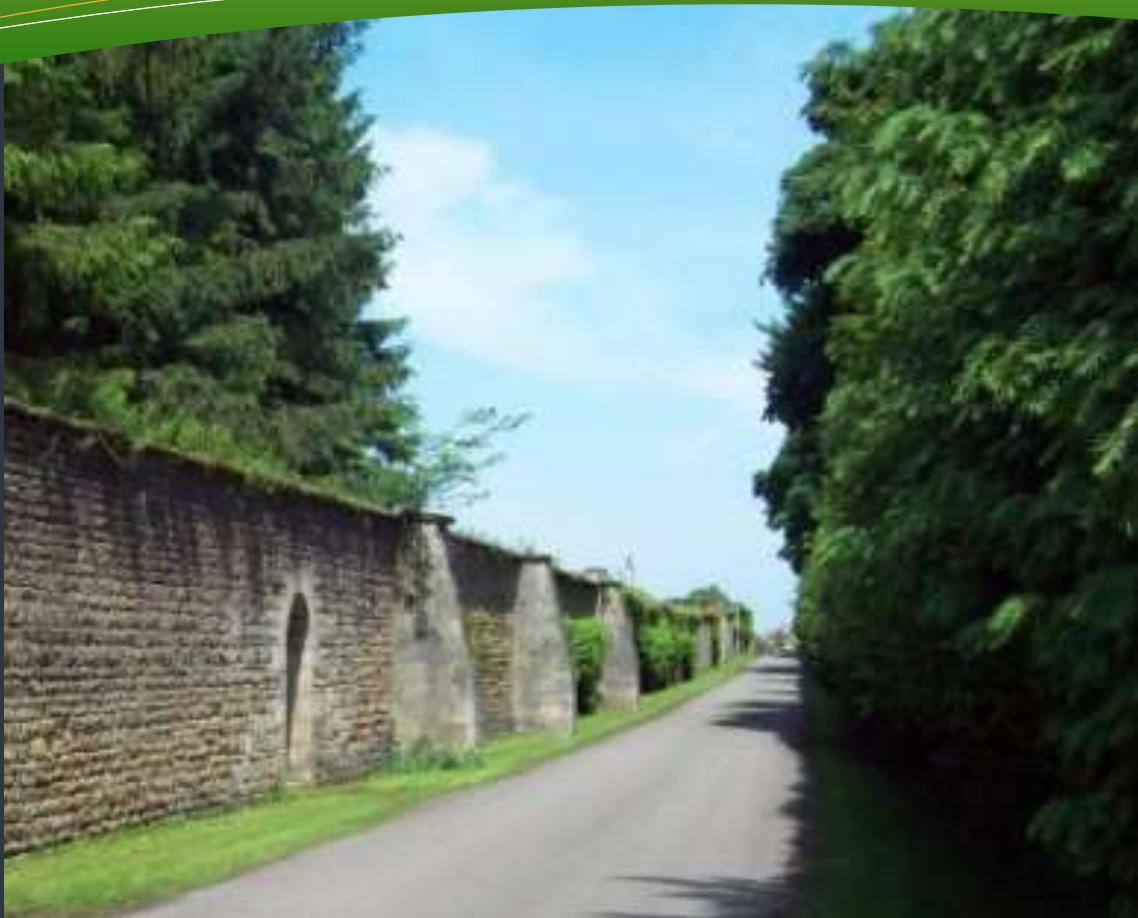
Sections of masonry in poor condition, notably to the drive walls where there has been partial collapse.

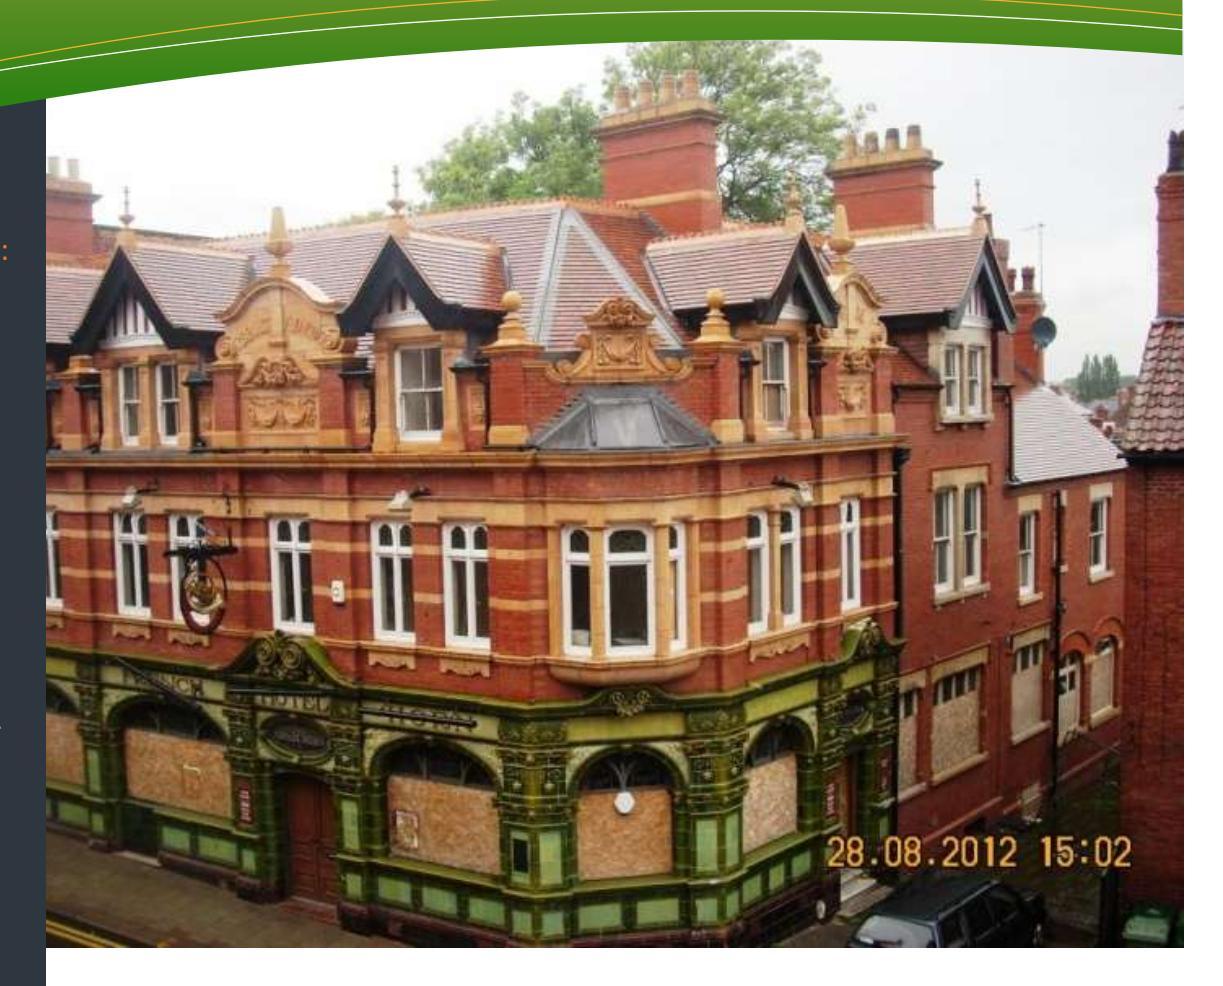
This building is vacant, with all ground floor windows boarded up. The roof has been fully repaired and stone work cleaned during summer 2011.

Draft urgent works notice issued to owner in summer 2009; repairs undertaken. Discussions regarding the future of the building are in progress.

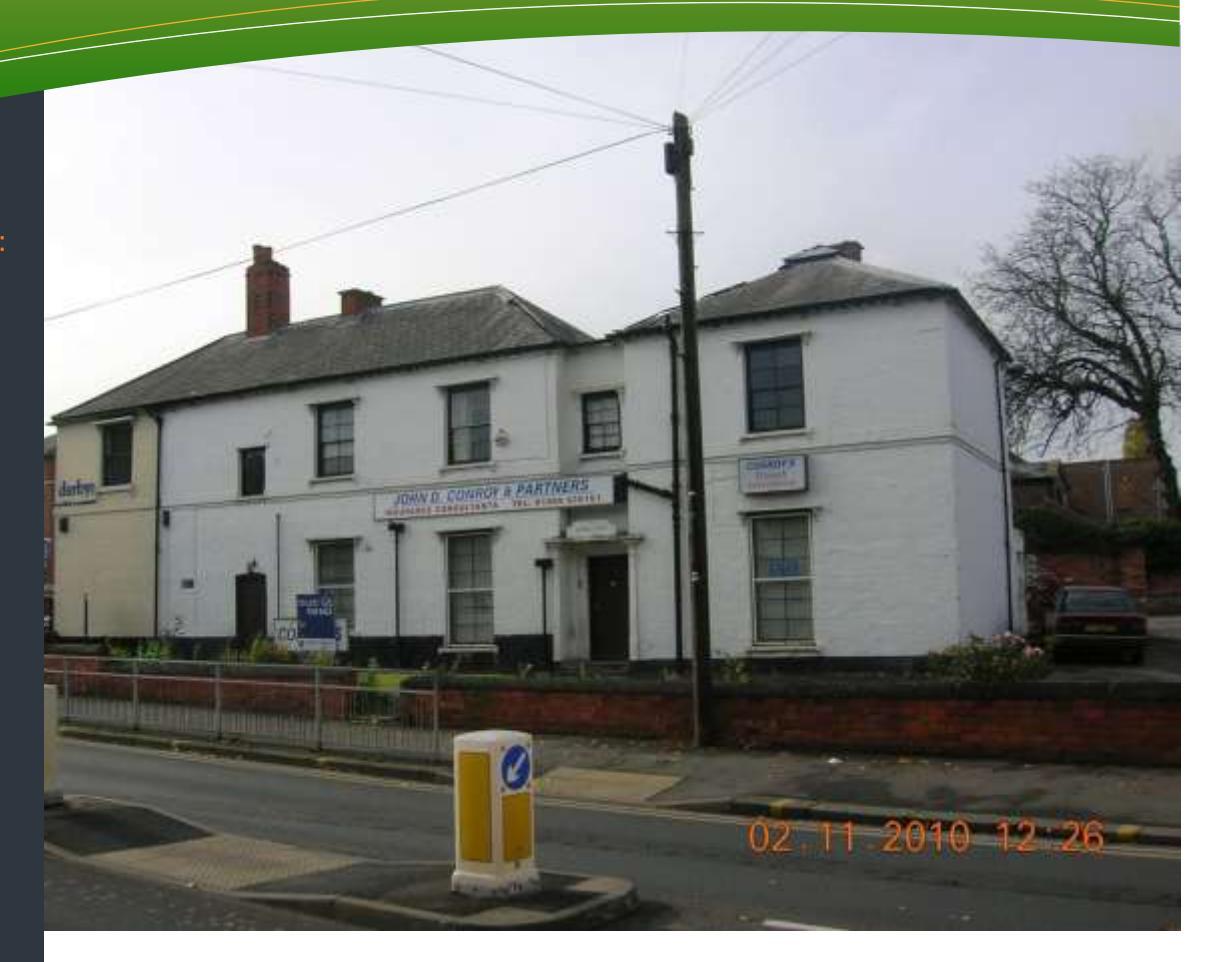
This building is vacant and in need of basic repairs.

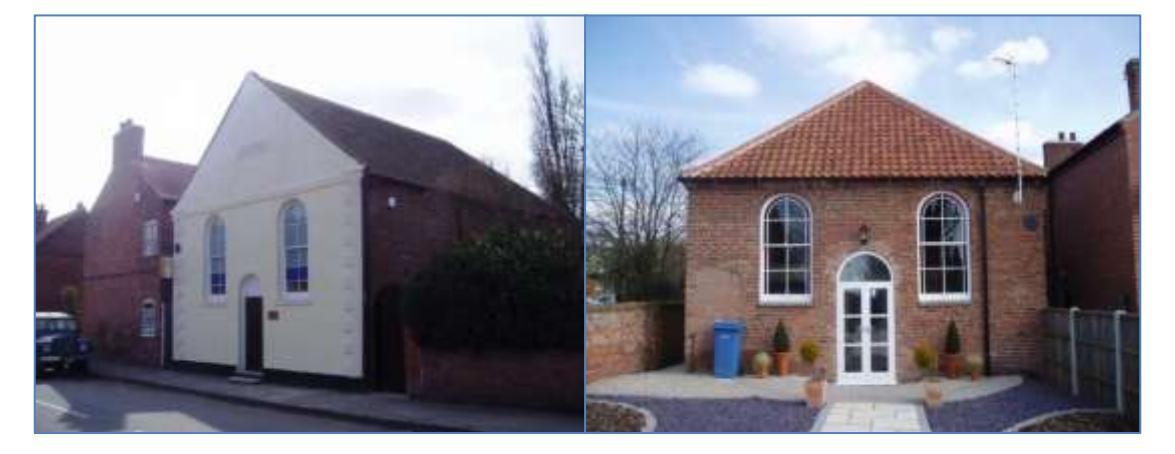
#### Clayworth Methodist Church, Town Street, Clayworth

The chapel following conversion.

Converted to a house in 2005/2006. Occupied and in good condition.

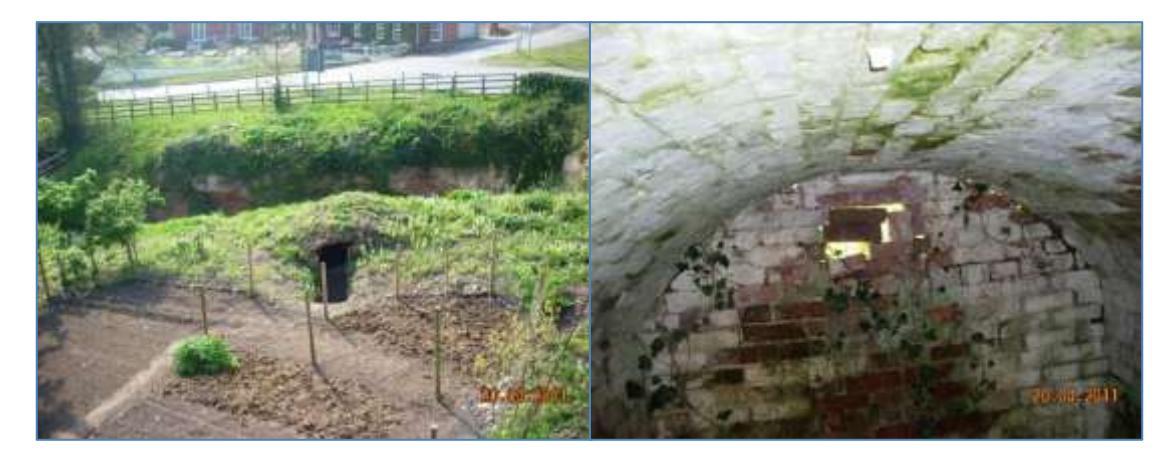
#### Ice-house at the gatehouse lodges, Drakeholes

The ice-house entrance and interior.

Foliage and debris removed from steps, walls and floor. In good condition and being maintained.

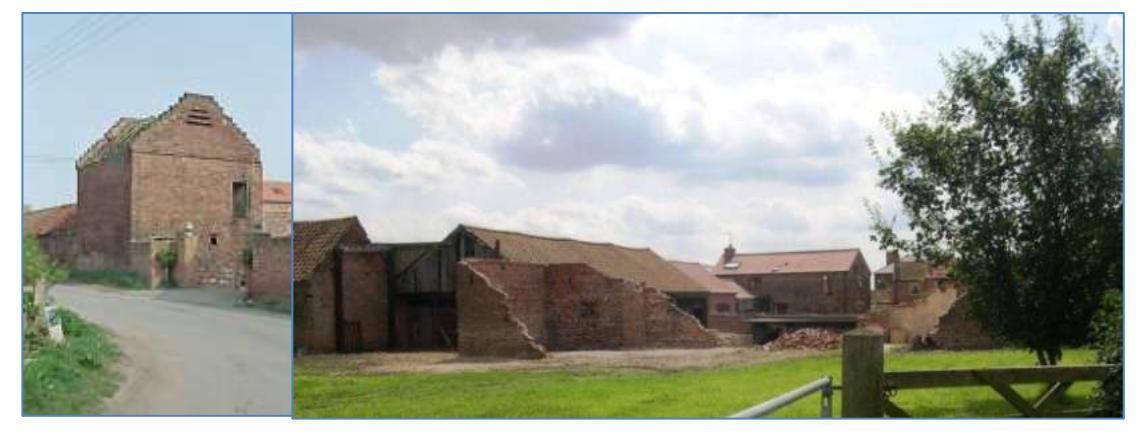
#### Pigeoncote at Manor Farm, Harwell Lane, Harwell

Pigeoncote totally demolished for safety reasons, allegedly following accidental structural collapse. Prosecution considered, but no further action taken. No structure remains.

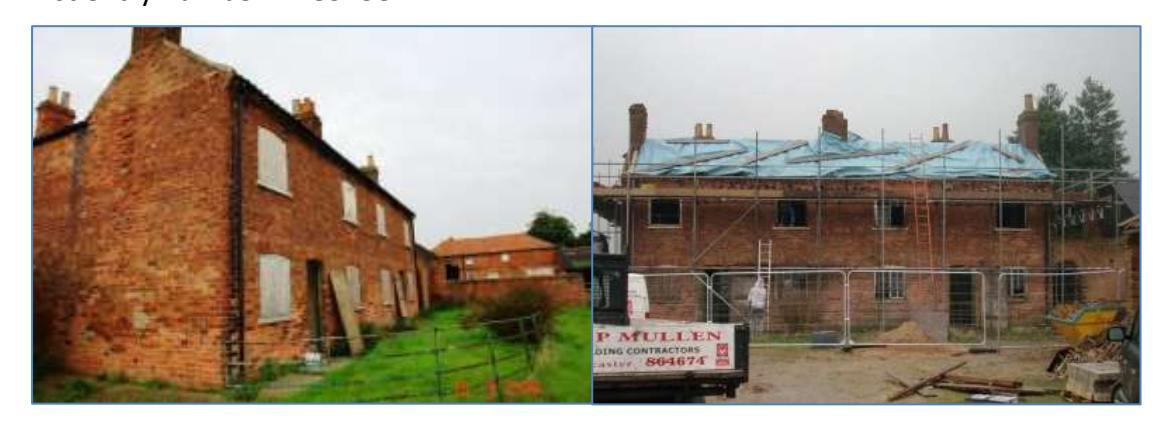
#### Pair of cottages at Mattersey Hill Farm, Ranskill Road, Mattersey Grade II List entry number: 1239193

The cottages before and during repairs

Fully repaired during 2010 and re-established as residential usage. Occupied and being maintained.

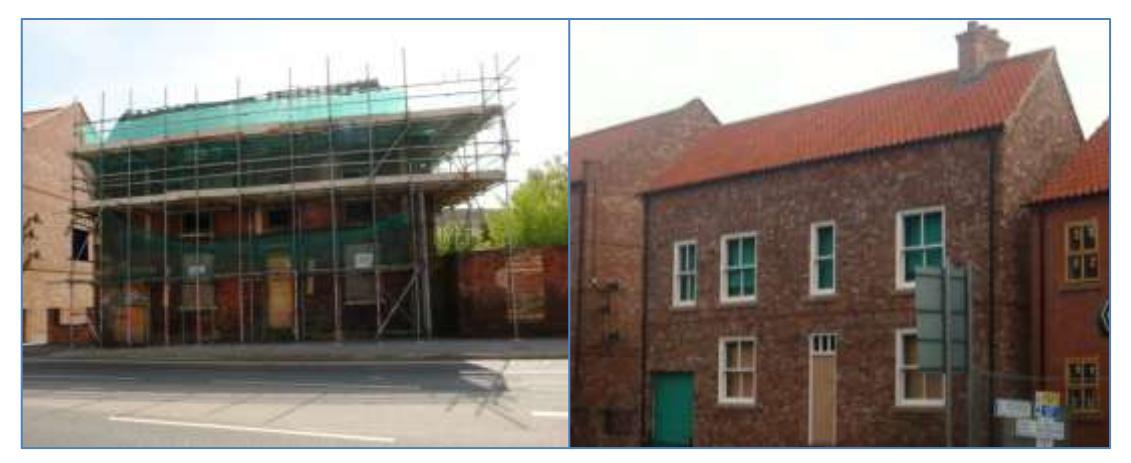
**24 Moorgate, Retford** Grade II, Retford CA List entry number: 1045160

Substantially demolished in 2011 and subsequently rebuilt through an enforcement notice. Soon to be occupied.
